Highland
RIDGE RV

Entrance Door Latch may not engage properly .

Recall #: 18V-688 2018-552

Make: Entegra Class A MH

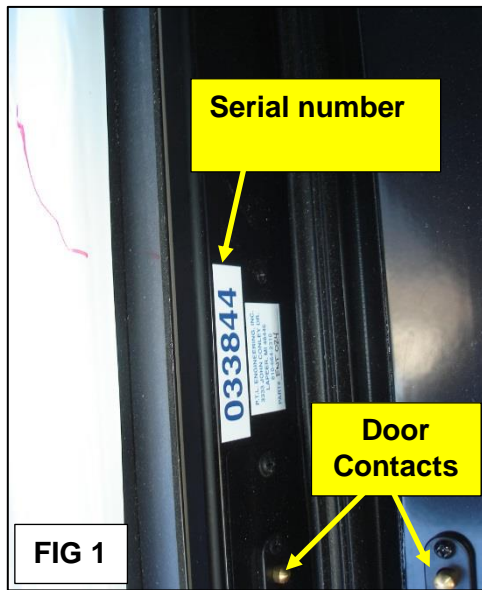
FIG 1: Open the entrance door to locate the door serial number tag. The tag is on the door jamb at the back of the door, just above the electrical door contacts.

Confirm door serial number on the entrance door is affected by this recall. Please reference the door manufacturer's list of affected serial numbers above.

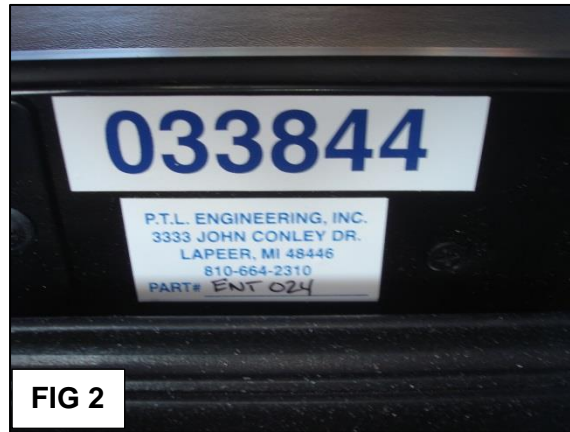
FIG 2: The serial number is a blue 6 number ID above the door manufacturer's label.
