PRODUCT CAMPAIGN BULLETIN

APPLICABILITY: 2018 Model Year Legacy and Outback Vehicles **NUMBER:** WTW-82R
SUBJECT: Combination Meter Reprogramming **NHTSA ID:** 18V-773
DATE: 12/11/18
REVISED: 02/20/19

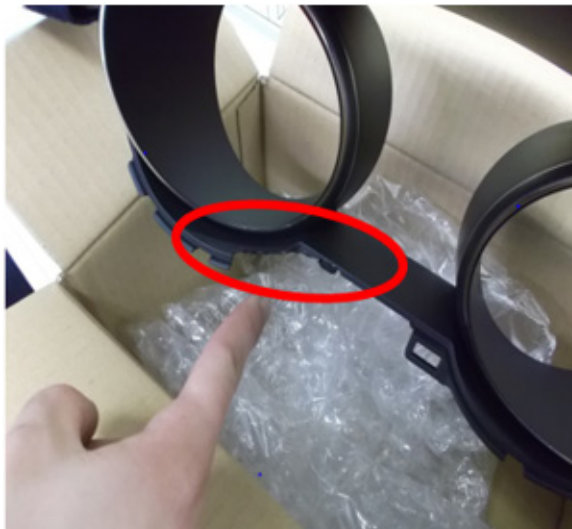
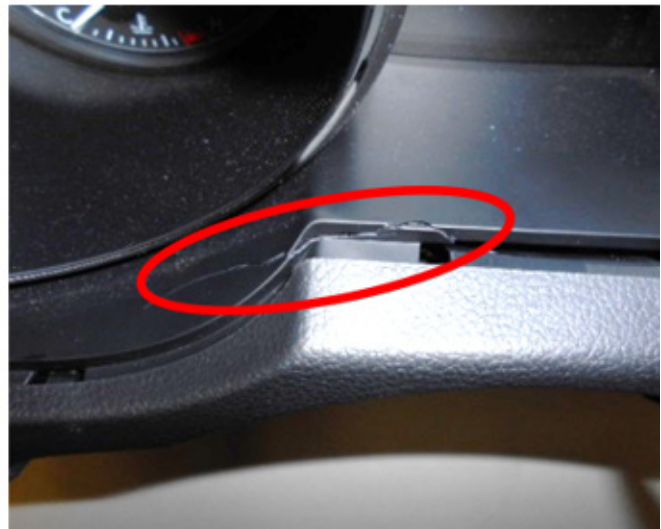
Reports of damaged meter housings as shown in the example photos below have necessitated revisions to this step.

REMINDER: Before proceeding to **Step 6** below, it cannot be stressed enough for Technicians to **TAKE THEIR TIME** when removing and reinstalling the combination meter. The photos below illustrate what can happen to the meter assembly when not performing these steps **CAREFULLY**. These 3 examples all show damage caused by outside influence which is not a matter for warranty.
