TO: Mercedes-Benz Dealer Principals, General Managers, Sales Managers, Service Managers, Parts Managers	FROM: Gregory Gunther, Department Manager, Vehicle Compliance and Analysis, Engineering Services
RE: <b>Recall Campaign Launch Notification</b> <b>Replace Electronic Power Steering Rack – Phase 1</b> <b>MY18-19 213, 238, 257 (E-Class, E-Class Coupe, CLS-Class)</b>	DATE: August 20, 2019

Campaign No. 2019080011, August 2019

SUBJECT: **Model E-Class (213 platform), E-Class Coupe (238 platform), and CLS-Class (238 platform)**  
**Model Years 2018-2019**  
**Replace Steering Rack**

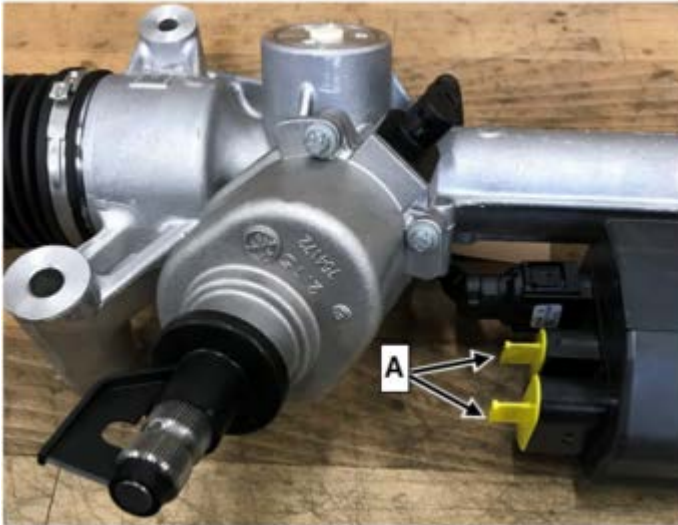
Figure 1

**i** To prevent dirt from entering the connector couplings or damage from ESD (electrostatic discharge), it is **absolutely essential** to fit the yellow dust caps (**A, Figure 1**) on the connector couplings of the steering gear to be returned. The **caps** from the **new** steering gear are to be used for this.
