Mercedes-Benz

Campaign No. 2019080011, August 2019

SUBJECT: **Model C-class (205 platform), E-Class (213 platform), E-Class Coupe (238 platform), and CLS-Class (257 platform)**  
**Model Years 2018-2019**  
**Replace Steering Rack**

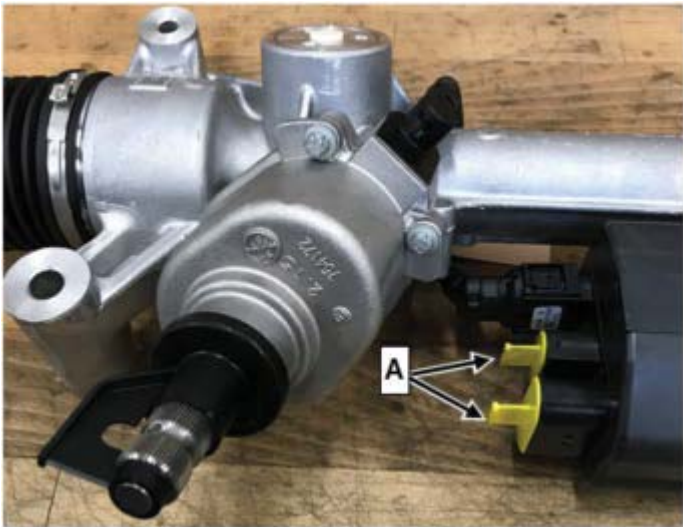
Figure 1

**i** To prevent dirt from entering the connector couplings or damage from ESD (electrostatic discharge), it is **absolutely essential** to fit the yellow dust caps (**A, Figure 1**) on the connector couplings of the steering gear to be returned. The **caps** from the **new** steering gear are to be used for this.
