Mercedes-Benz

Campaign No. 2019070013, December 2019

SUBJECT: **Model C-class (205 platform), E-Class (213 platform), and E-Class Coupe (238 platform).**
Model Years 2015-2018
Replace Steering Rack

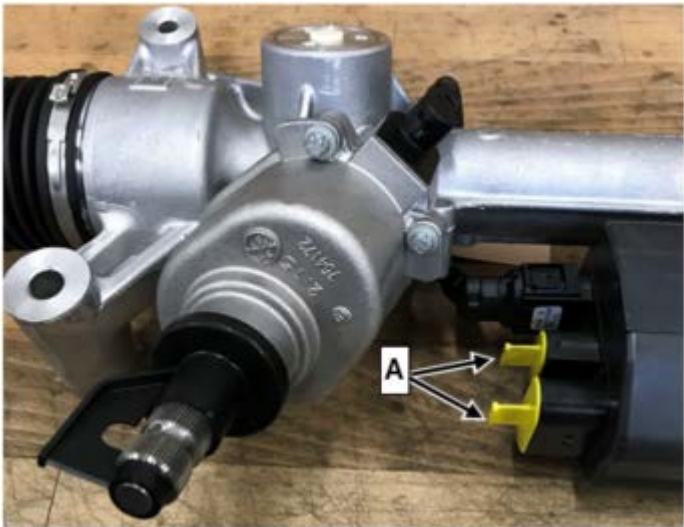
Figure 1

i To prevent dirt from entering the connector couplings or damage from ESD (electrostatic discharge), it is **absolutely essential** to fit the yellow dust caps (**A, Figure 1**) on the connector couplings of the steering gear to be returned. The **caps** from the **new** steering gear are to be used for this.

i If these dust caps are **not** fitted, it will **not** be possible to carry out an analysis.
This could affect the warranty process.
