Product Safety Recall

N182198820 Passenger Airbag Underinflated

Release Date: December 2018

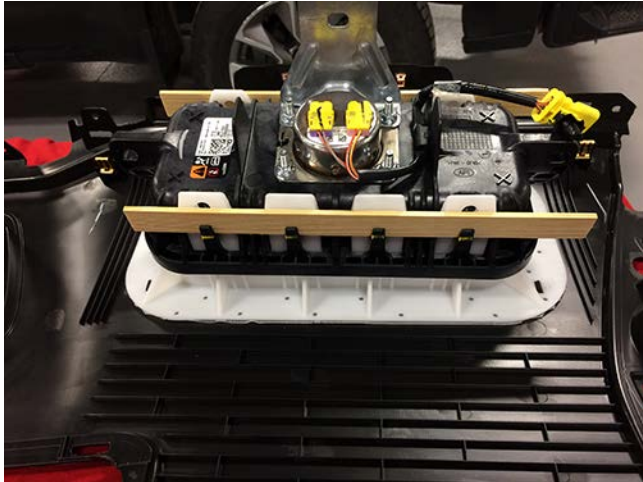
5185381

Wood Straight Edge Inserted Per ESI Procedure
