**IMPORTANT SAFETY RECALL – 19E-009**

Subject: Part 573 Defect Information Report for ASA Electronics, LLC Company Recall Number 19E-009 – Certain 2017-2018 Voyager brand VOM74MM Mirror Monitors.

49 CFR Part 573 – DEFECT INFORMATION REPORT 19E009 –  
CERTAIN 2017-2018 VOYAGER BRAND VOM74MM MIRROR MONITORS HAVE THE  
IMAGE INVERT – REVERSE IMAGE DISPLAYED ON MONITOR

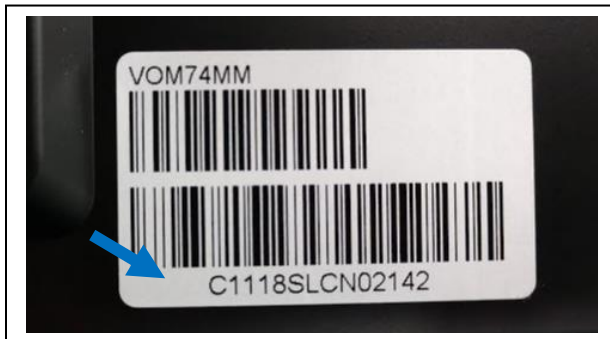
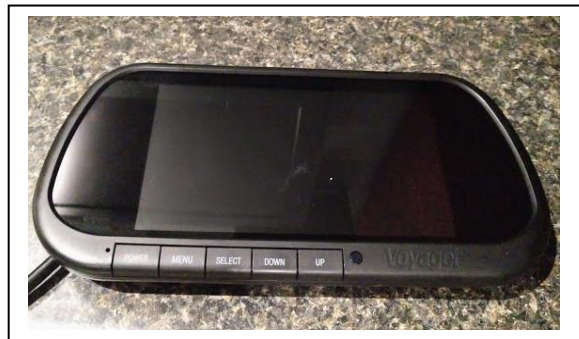
From June 2017 to December 28<sup>th</sup> 2018, ASA sold Voyager VOM74MM Mirror Monitors to you which were involved in a recall. The serial numbers associated with the mirror monitors start with an “A”, “B”, or “C”.

As the monitor powers up (takes a few seconds) at a specific time it loads the user defined settings. If the power up sequence is interrupted by a power drop at a precise time the monitor may not be able to load the user settings and will load the default settings which will reverse the image on the monitor. The user defined setting for image is "NORMAL". The factory default setting for image is "MIRROR". The monitor image will stay in "MIRROR" mode until the user selects "NORMAL" in the settings.

ASA has a harness/relay/capacitor repair kit available, at no cost to you. Our customer service representatives are available to contact your dealer, owner operator, or fleet service center customers and schedule to have the repair kits sent to them directly. Please contact **1-877-384-4400** or [recall@asaelectronics.com](mailto:recall@asaelectronics.com) to schedule the shipment of field repair kits. Our hours of operation are Monday through Friday 7AM to 6PM (EST).
