IMPORTANT SAFETY RECALL – 19E-009

Subject: Part 573 Defect Information Report for ASA Electronics, LLC Company Recall Number 19E-009 – Certain 2017-2018 Voyager brand VOM74MM Mirror Monitors.

49 CFR Part 573 – DEFECT INFORMATION REPORT 19E009 –
CERTAIN 2017-2018 VOYAGER BRAND VOM74MM MIRROR MONITORS HAVE THE
IMAGE INVERT – REVERSE IMAGE DISPLAYED ON MONITOR

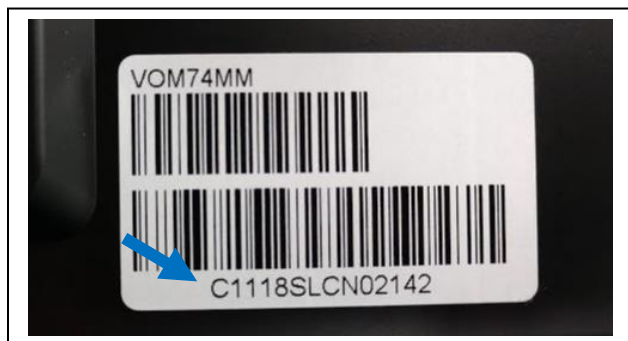
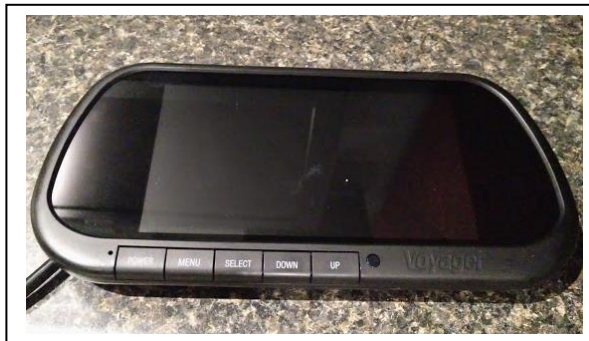
From [DATE] to [DATE], ASA sold [XX] Voyager VOM74MM Mirror Monitors to [COMPANY NAME], in which you purchased. The serial numbers associated with the mirror monitors start with an “A”, “B”, or “C”.

In accordance with the requirements of 49 CFR Part 573 Defect and Noncompliance Information Reports, please find the attached information regarding ASA’s voluntary safety recall number 19E009 to address the potential for a mirror monitor to load default factory settings and cause the monitor to reverse the image displayed on the mirror monitor. **Do not rely on the image displayed until the monitor has a field fix implemented.**

As the monitor powers up (takes a few seconds) at a specific time it loads the user defined settings. If the power up sequence is interrupted by a power drop at a precise time the monitor may not be able to load the user settings and will load the default settings which will reverse the image on the monitor. The user defined setting for image is "NORMAL". The factory default setting for image is "MIRROR". The monitor image will stay in "MIRROR" mode until the user selects "NORMAL" in the settings.

ASA has a harness/relay/capacitor repair kit available, at no cost to you. Our customer service representatives are available to contact your dealer, owner operator, or fleet service center customers and schedule to have the repair kits sent to them directly. Please contact **1-800-384-4400** or recall@asaeelectronics.com to schedule the shipment of field repair kits. Our hours of operation are Monday through Friday 7AM to 6PM (EST).
