**Technical Service Bulletin 19 002
Spartan Motors**

Date: 07/17/2019

Subject: Upper Shock Mounting Hardware

Applies To: Fire Truck IFS 20k and 24k Models

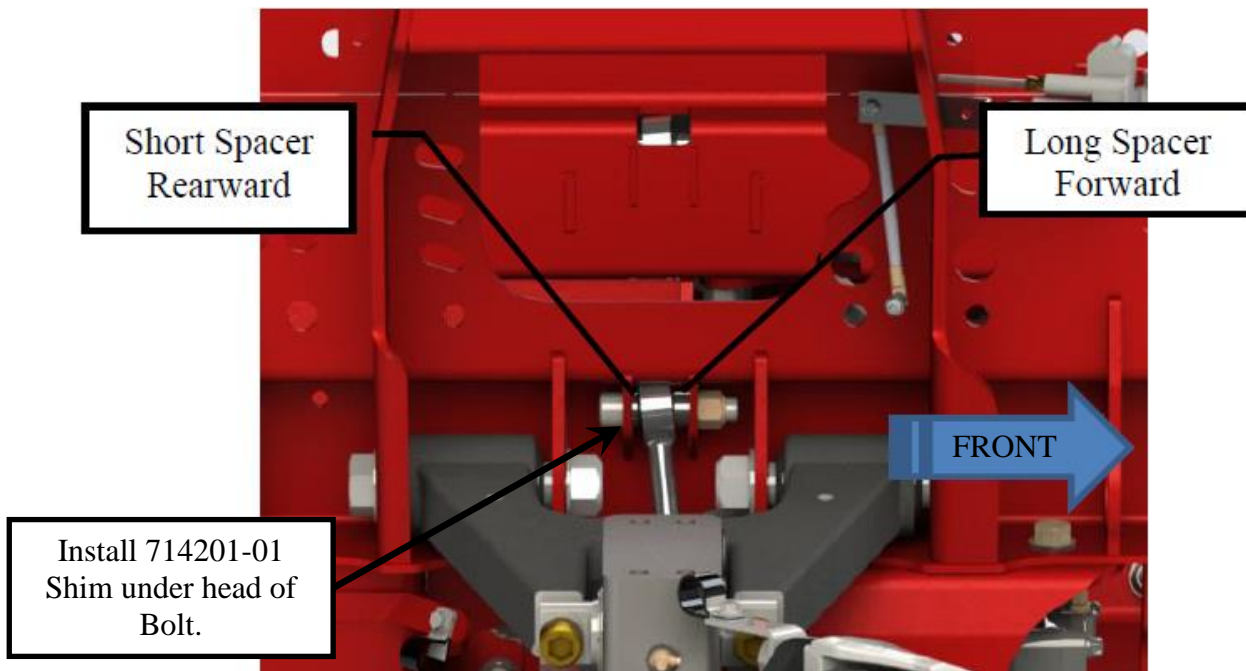
Right side assembly shown

Condition: The upper shock mounting hardware may come loose over time due improper joint clamp load.

3. Install new hardware including spacers and shims from kit #K715180 as shown below.
 - a. **Note:** One 714201-01 shims must be installed under the head of each 715176-01 Bolt.

- b. **Assembly tip:** Insert bolt through the rear tab enough to hang needed shims and short spacer, place shock in position, advance bolt to engage shock, position long spacer, push bolt through front tab, and install nut.
