Product Safety Recall

N192223230 Incorrect Service Ignition Key

Release Date: January 2020

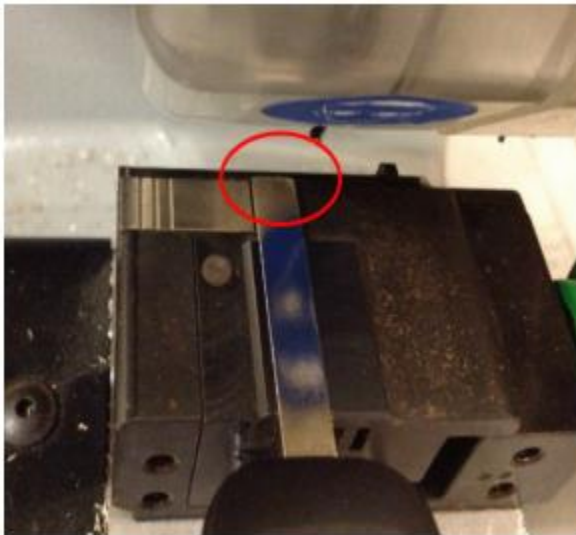
3947698

Note: The key blank should fit into the Jaw as shown in the picture. Make sure there is no gap in the area circled in the picture. Remove the guard if necessary.

- 2.1. Select “key search”
- 2.2. Choose “car, model” selection
- 2.3. Enter make, model & hit enter
- 2.4. Select “cut by decode”
- 2.5. Insert the original key into Jaw “C” and change cutter, if necessary
