# Product Safety Recall

## N192261860 Tonneau Cover Retention

**Release Date:** January 2020

**Revision:** 01

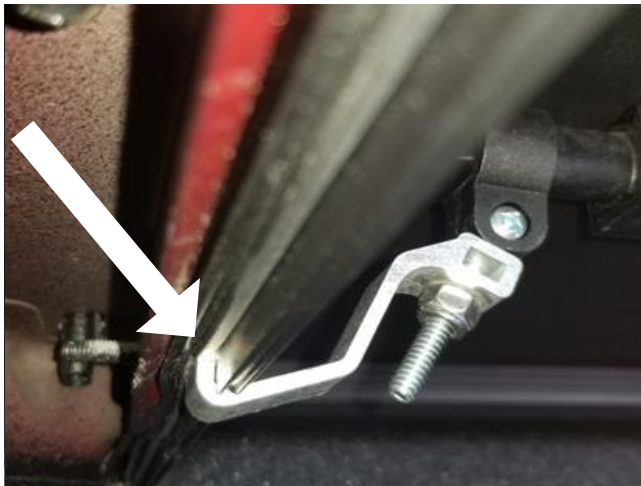
5448625

**Incorrect installation of bracket clamp hook**

8. If any of the above inspections indicate an incorrect clamp hook installation, loosen the nut on the threaded mount and position the clamp hook in the correct position. Hand tighten the fasteners.
9. Position the cover evenly side to side and rest the cab seal smoothly along the front top edge of the cargo bed.
10. Tighten the nuts until the clamp hooks are secure against the bed rail flange. Tighten each side evenly, tighten only until the tonneau cover cannot shift. **DO NOT** overtighten, overtightening may cause damage to the clamping system.
11. Close the tonneau cover and tailgate.
