## Safety Recall Action Notice SB568 Issue 1 - 11.2019

Subject: Gear Linkage Clamp Assembly Replace				
Notice Number	Models Affected	VIN Range		Markets Affected
568	Speed Triple S	From	867685	All markets
		Up to	957570	
568	Speed Triple RS	From	867601	All markets except US and Canada
		Up to	971378	
Dealer Stock Accessory Kits To Be Returned				
Part Number		Description		
A9930469		Accessory Quickshifter Kit, TSA

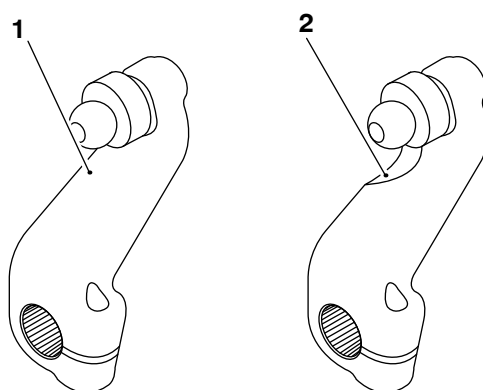
If an Accessory Quickshifter Kit, TSA is fitted, dealers must check for a scallop on the gear linkage clamp assembly as illustrated below.

1. **Recalled part - Linkage clamp assembly, T2085085 (without scallop) - Referred to throughout as Gear Linkage Clamp Assembly**
2. **Remedy part - Linkage clamp assembly, T2085100 (with scallop) - Referred to throughout as Gear Linkage Clamp Assembly**

If a scallop exists on the gear linkage clamp assembly, no further action is necessary.

If no scallop exists, dealers are required to replace the gear linkage clamp assembly as described in the procedure below.

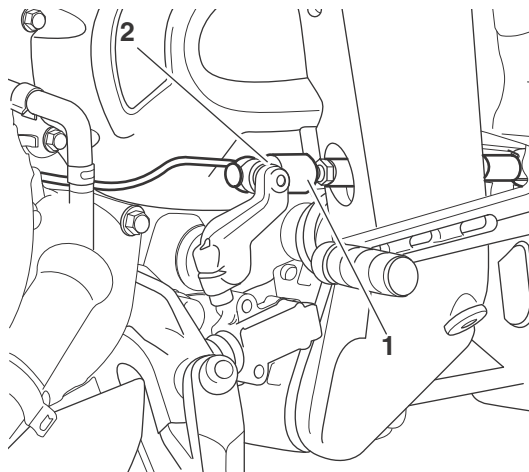
1. **TSA shift force sensor**
2. **Front wire clip position**

1. Remove the wire clip retaining the TSA shift force sensor front ball joint. Retain the wire clip for reuse.

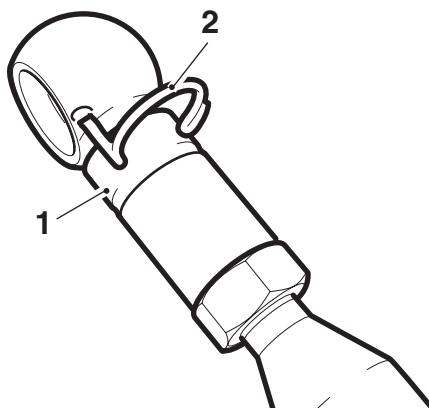
1. **TSA shift force sensor**
  2. **Wire clip**
2. Release the TSA shift force sensor from the gear linkage clamp assembly and allow the TSA shift force sensor to move rearwards and rest inside the frame.

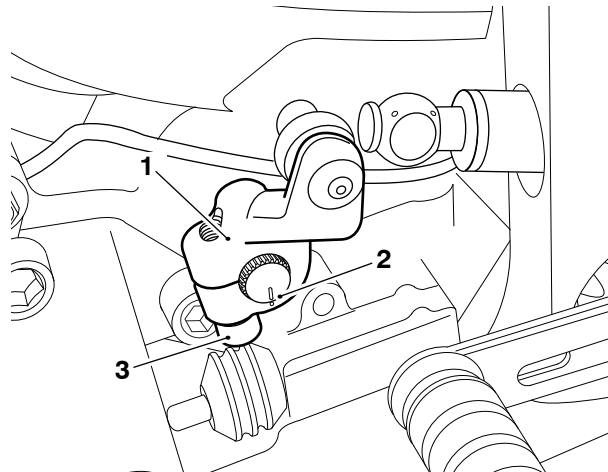
1. Gear linkage clamp assembly (T2085085)
2. Alignment marks
3. Fixing

- 
3. Remove and retain the gear linkage clamp assembly fixing. Remove the gear linkage clamp assembly (T2085085).

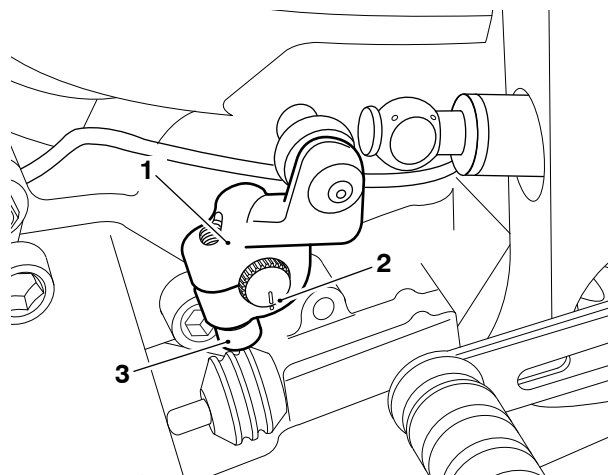
1. Gear linkage clamp assembly (T2085100)
  2. Alignment marks
  3. Fixing
2. Install the clamp fixing and tighten to **8 Nm**.

1. Make sure the alignment mark on the gear shaft assembly aligns with the alignment mark on the gear linkage clamp assembly (T2085100) and install the clamp to the shaft.

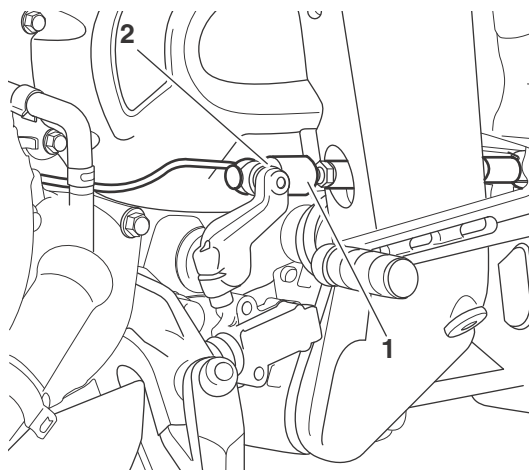
1. TSA shift force sensor
2. Front wire clip position

3. Make sure the ball joint is clean and free from debris and attach the TSA shift force sensor front ball joint to the gear linkage clamp assembly.

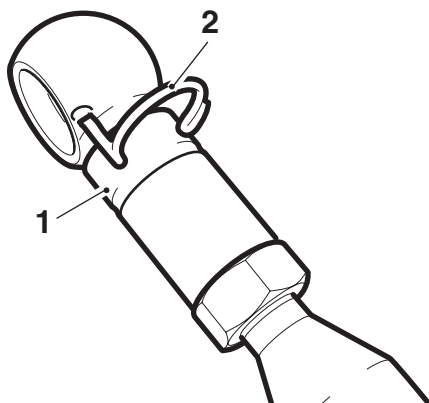
1. TSA shift force sensor
2. Wire clip

4. Refit the wire clip to retain the front ball joint. Make sure the wire clip locates correctly in the ball joint before rotating the clip to lock in place.
