RECALL CAMPAIGN INSTRUCTIONS

REF. NO. C24100065 TAKATA PASSENGER FRONTAL AIR BAG MODULE

MODEL YEAR 2014 – 2015 – 2016 – 2017 – 2018

MARCH 2019

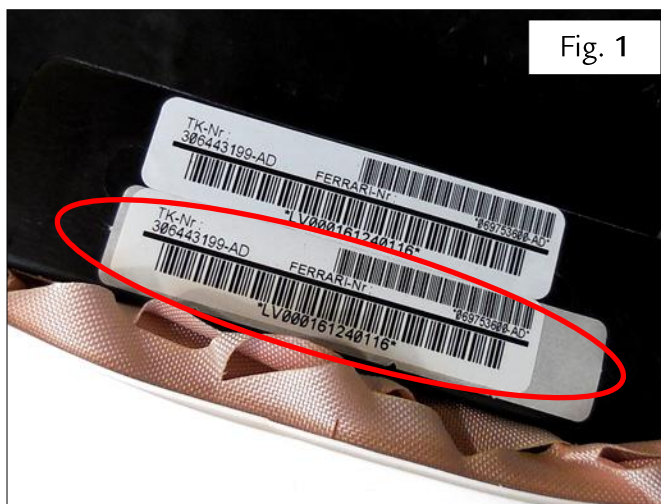
- 1.1. Remove the label with the airbag identification details, shown in the photo aside, from the new airbag and affix it in the relative space in a printout of the “Passenger side front airbag module replacement traceability form” included in this booklet. The serial of the new airbag must also be reported in the Traceability session of New Modis.

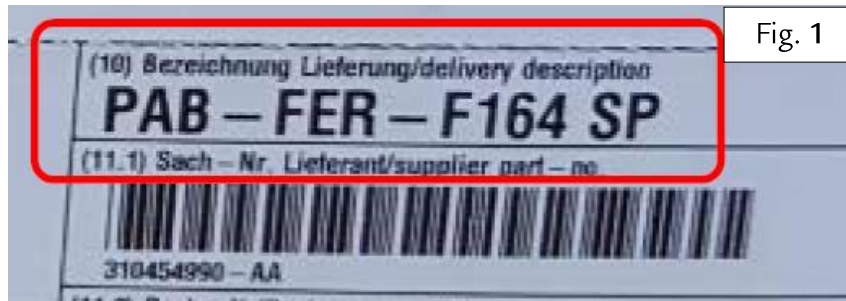
The new component is marked with a specific label bearing the phrase "PAB-FER-F164 SP" on the packaging (see Fig. 1 below).

- 1.4. The installation of the new airbag module P/N 70004993 requires the use of a special bracket to mount the airbag to the dashboard. See the Overview section of this booklet for the bracket part numbers as well as the hardware part numbers.

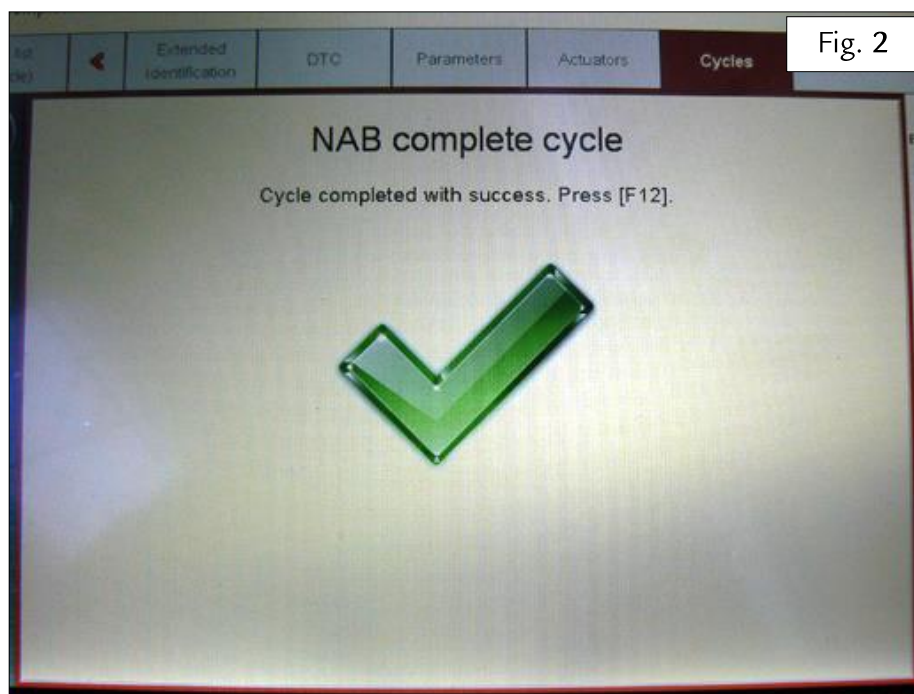
1.8. Ensure that the cycle is completed successfully (see Fig. 2 below).

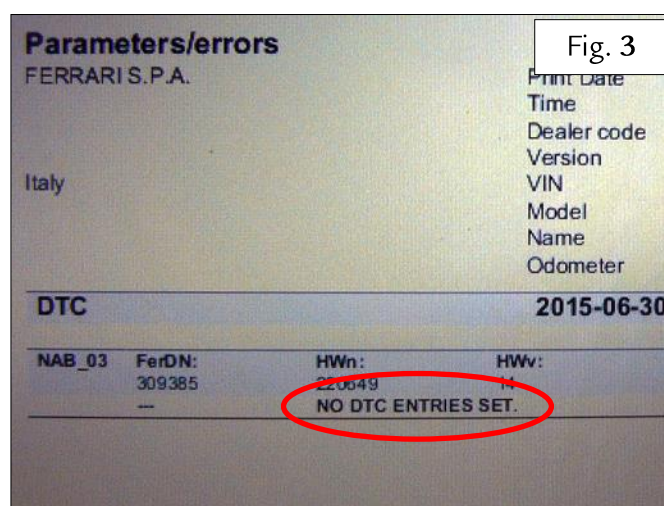
1.9. Access the “DTC” area of the DEIS Tester relative to the “NAB” airbag ECU, select “Save”, “Preview” and “Print” in the sequence given and check that there are no active errors in the ECU memory (see Fig. 3).

Note: If any errors are stored, open an ROL with the description “Technical Support”, attaching the file generated.

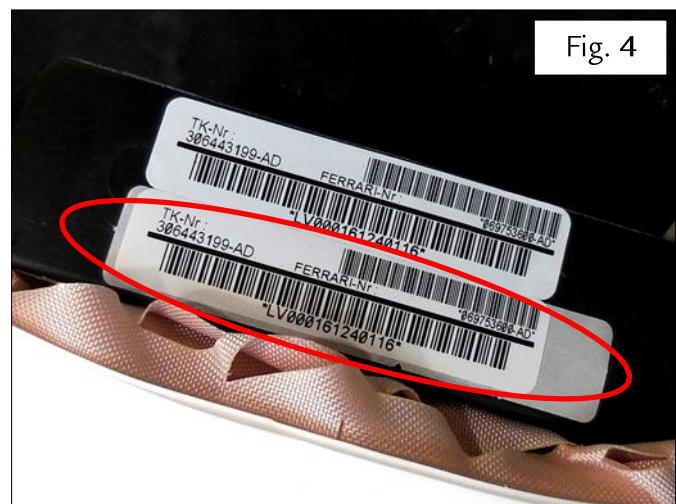
2.1. Remove the label with the airbag identification details, shown in the photo aside, from the new airbag and affix it in the relative space in a printout of the “Passenger side front airbag module replacement traceability form” included in this booklet. The serial of the new airbag must also be reported in the Traceability session of New Modis.

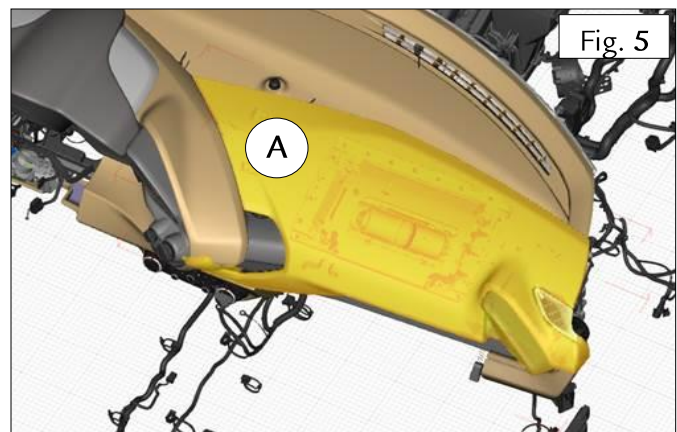
2.3. Disassemble the upper dashboard panel, passenger side (as described paragraph E4.02 of the Workshop Manual) - Fig. 5.

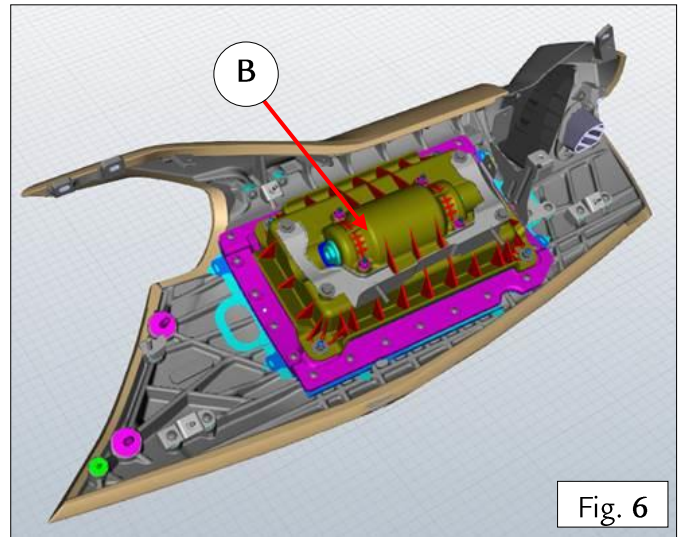
- 2.4. Disassemble the passenger airbag (B) (as described in paragraph F4.02 of the Workshop Manual) – Fig. 6.

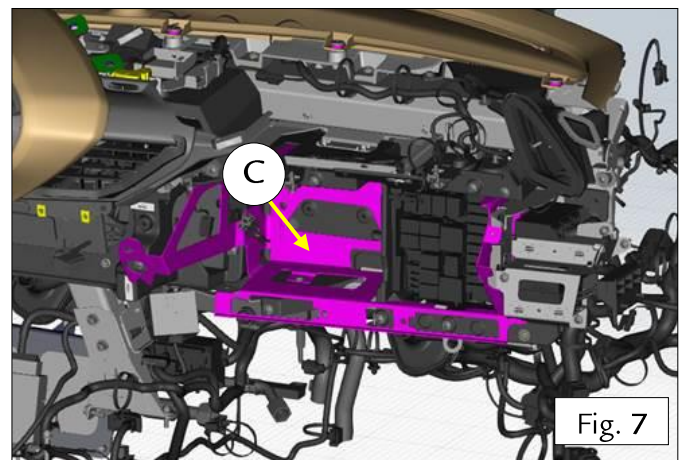
- 2.5. Disassemble the US-specific drawer compartment reinforcement bracket (C) – Fig. 7.

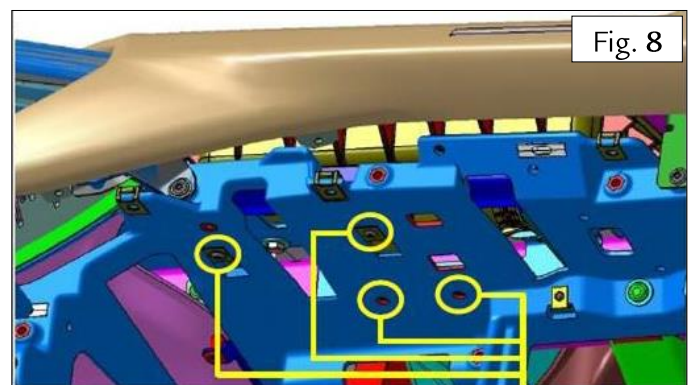
- 2.6. Undo the four indicated screws that fix the airbag reinforcement bracket to the lower dash panel – Fig. 8.

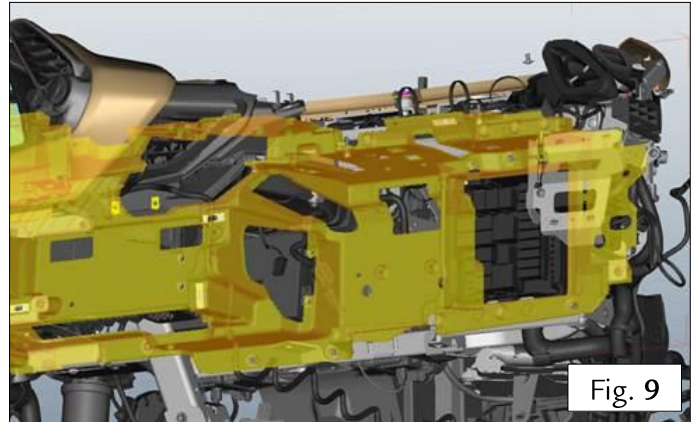
Fig. 9

- 2.7. Remove the lower dashboard frame (as described in paragraph E4.02 of the Workshop Manual) – Fig. 9.

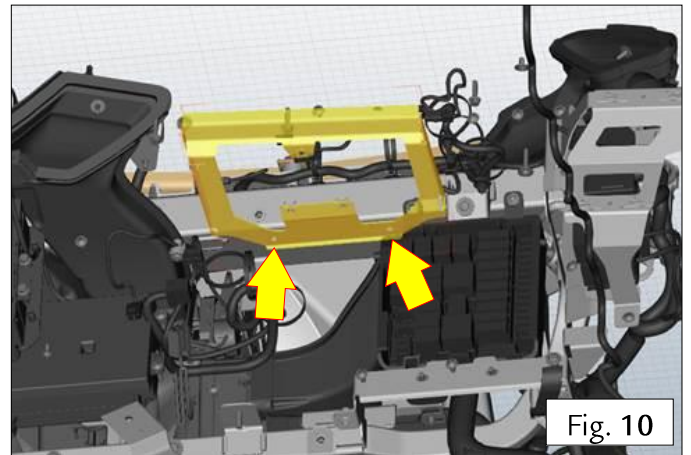
Fig. 10

- 2.8. Undo the two indicated screws and remove the airbag reinforcement bracket – Fig. 10.

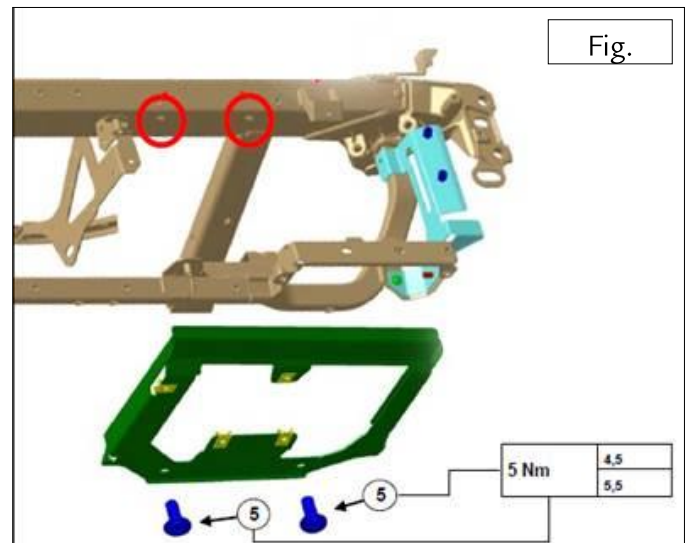
- 2.9. Install the new airbag reinforcement bracket code 745714 using the Raymond brackets code 67278400. Tight the indicated screws to the torque of 5 Nm Class B– Fig. 11.

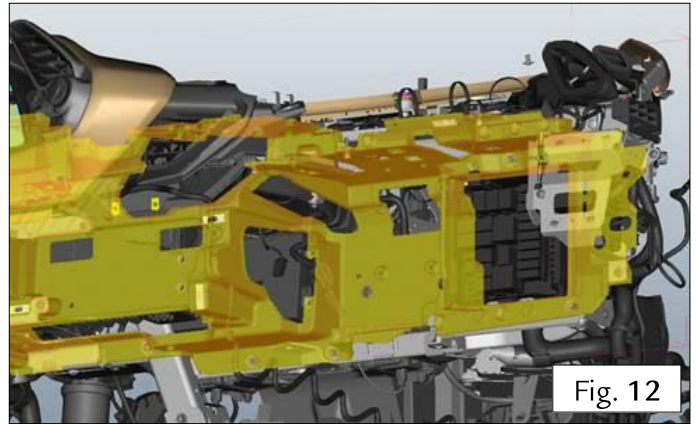
- 2.10. Reassemble the lower dashboard frame (as described in paragraph E4.02 of the Workshop Manual) – Fig. 12.

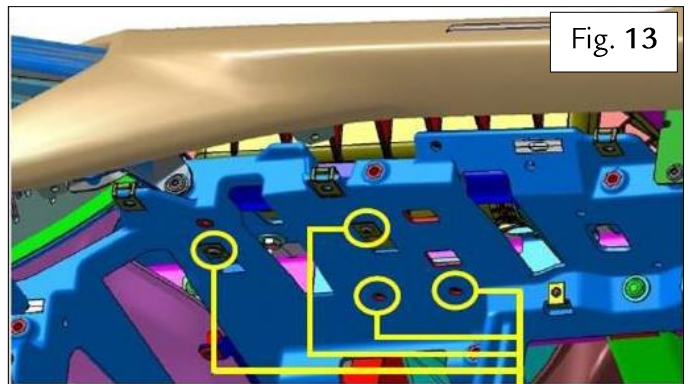
- 2.11. Tight the four indicated screws that fix the airbag reinforcement bracket to the lower dash panel to the torque of 4 Nm Class B – Fig. 8.

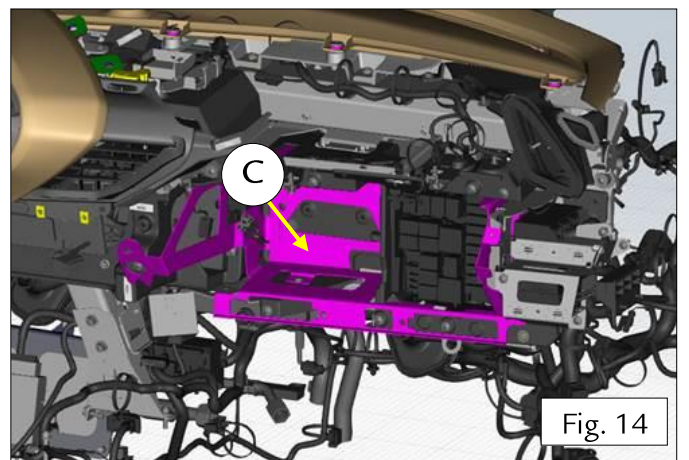
- 2.12. Reassemble the US-specific drawer compartment reinforcement bracket (C) – Fig. 14.

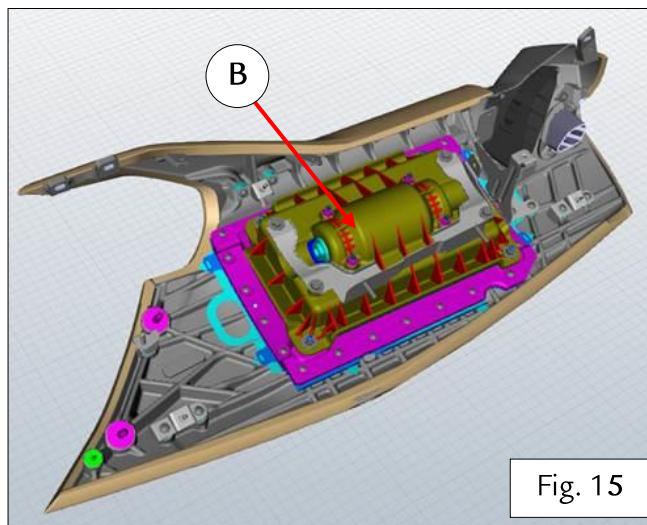
- 2.13. Reassemble the new passenger airbag (B), with the new bracket (as described in paragraph F4.02 of the Workshop Manual) – Fig. 15.

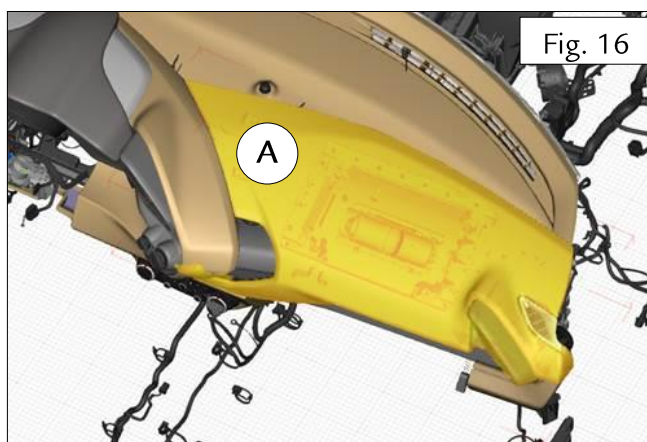
- 2.14. Reassemble the upper dashboard panel, passenger side (as described paragraph E4.02 of the Workshop Manual) - Fig. 16.

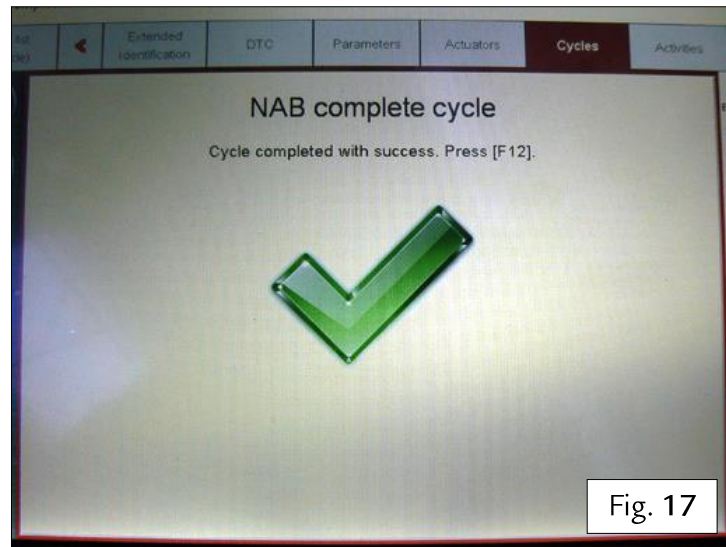
2.18. Ensure that the cycle is completed successfully – Fig. 17.

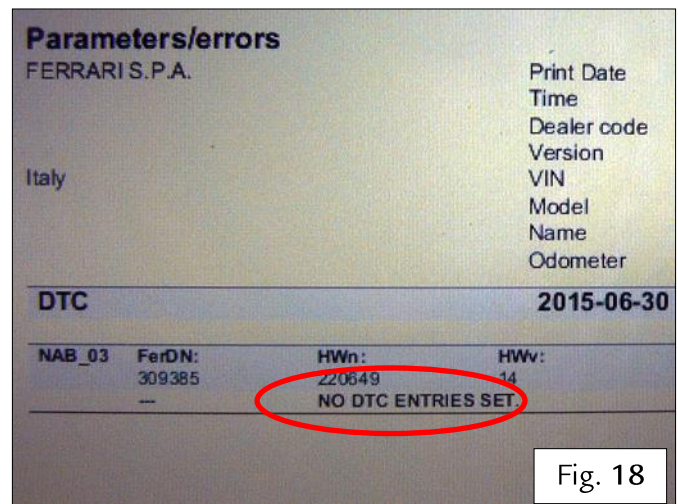
2.19. Access the “DTC” area of the DEIS Tester relative to the “NAB” airbag ECU, select “Save”, “Preview” and “Print” in the sequence given and check that there are no active errors in the ECU memory – Fig. 18.

N.B.: if any errors are stored, open an ROL with the description “Technical Support”, attaching the file generated.
