PRODUCT CAMPAIGN BULLETIN

<p>APPLICABILITY: 2010-2014 MY Legacy 2010-2014 MY Outback 2010-2013 MY Forester 2010-2014 MY Tribeca 2010-2011 MY Impreza 2010-2014 MY WRX and STI</p> <p>SUBJECT: Takata Front Passenger Airbag Module / Inflator Replacement (2019 Calendar year expansion)</p>	<p>NUMBERS: TKA-19 TKB-19 TKC-19</p> <p>DATE: 01/14/19</p> <p>REVISED: 04/10/19</p> <p>NHTSA ID: 19V-007 19V-008 19V-009</p>
--	--

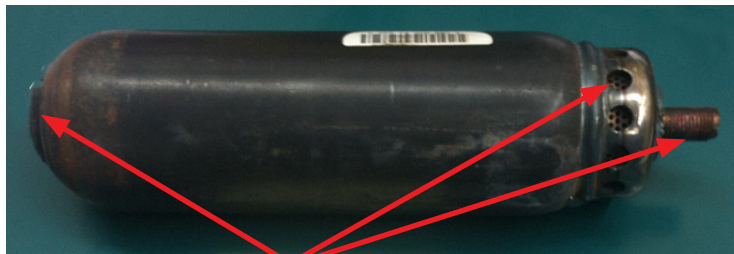
The shape, holes, and copper-colored stud indicate this not a Genuine Subaru inflator.

- **Do not proceed with this repair if your inspection reveals a non-Genuine Subaru airbag module has been installed in the vehicle.** Follow the instructions described in the “Counterfeit Airbag Information” Dealer Advisory Bulletin.

- Document the presence of the aftermarket or counterfeit device on the repair order and with photos. Report this information immediately on a Quality Monitoring Report (QMR). **IMPORTANT:** When entering a related QMR, use failure code **ULF** and **NOT** the campaign fail code.
