Safety Recall

Code: 69S8

Subject	Driver Frontal Airbag Inflator (Takata)
Release Date	March 29, 2019
Affected Vehicles	U.S.A. & Canada: Certain 2017 MY Audi R8 Spyder and Audi R8 Coupe and Certain 2016-2017 MY Audi TT Roadster and Audi TT Coupe <i>Check Campaigns/Actions screen in Elsa on the day of repair to verify that a VIN qualifies for repair under this action. Elsa is the <u>only</u> valid campaign inquiry & verification source.</i> <ul style="list-style-type: none">✓ Campaign status must show "open."✓ If Elsa shows other open action(s), inform your customer so that the work can also be completed at the same time the vehicle is in the workshop for this campaign.
Problem Description	The driver airbag may explode in a crash with airbag deployment. Sharp metal fragments can hit people and cause serious injury or death.
Corrective Action	Replace the driver frontal airbag.
Code Visibility	On March 29, 2019 affected vehicles will be listed on the Inventory Vehicle Open Campaign Action report under My Dealership Reports (found on www.accessaudi.com & OMD Web). A list was not posted for dealers who did not have any affected vehicles. On March 29, 2019, this campaign code will show

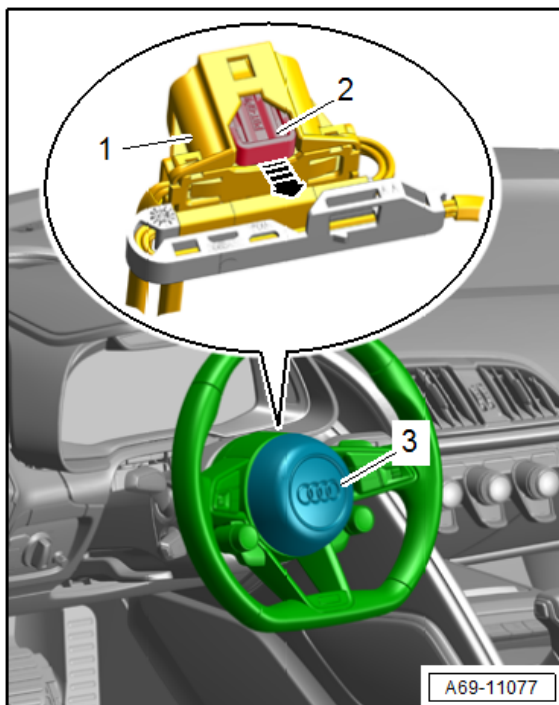
- The driver frontal airbag inflator could potentially rupture (due to propellant degradation occurring after long-term exposure to absolute high humidity and temperature cycling). In the event of an inflator rupture, in very rare cases metal fragments could pass through the airbag cushion material, which may result in serious injury or death.
- All Takata recalls should be performed before any other work is performed on the vehicle.

- Replace driver frontal airbag <3>.
