SIB 65 05 19

RECALL 19V-015: DRIVER'S FRONT AIR BAG MODULE – PRIOR PARTS REPLACEMENT

RECALL CAMPAIGN 19V-015: DRIVERS FRONT AIR BAG MODULE – PRIOR PARTS REPLACEMENT

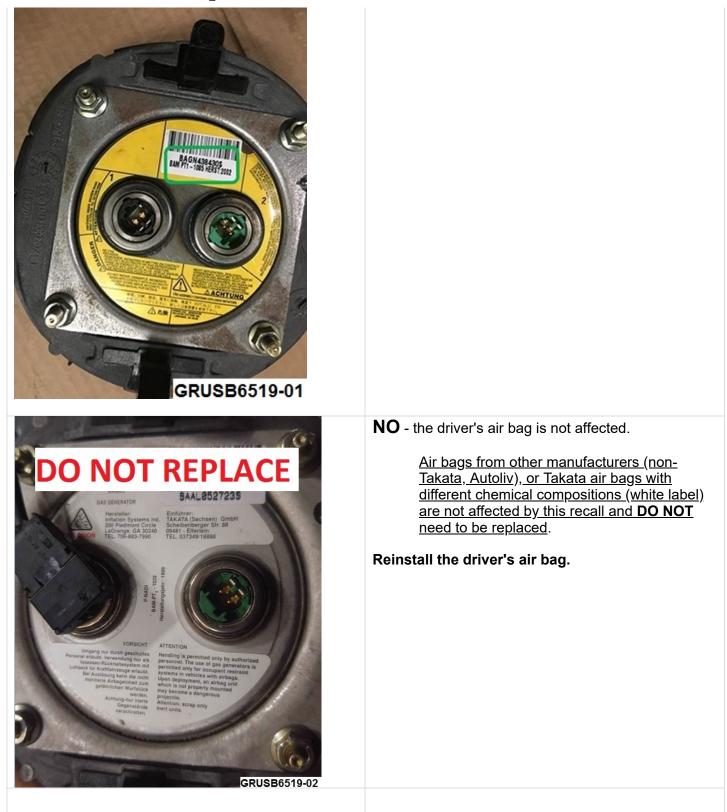
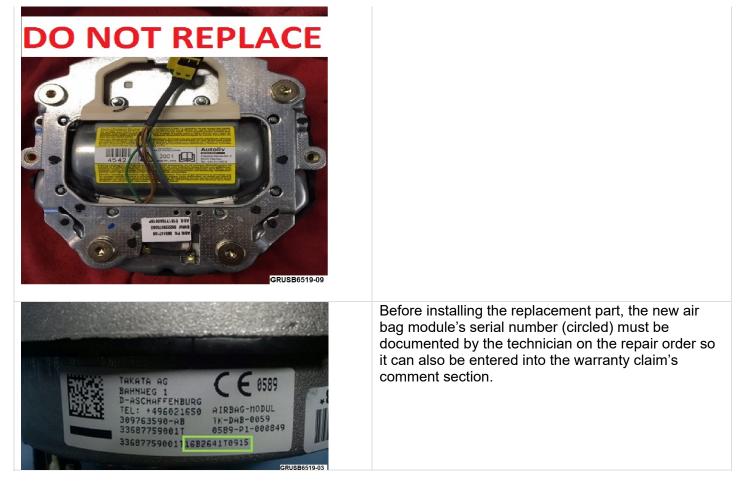
Basic Steering Wheel Equipped Vehicles (with or without MFL button controls)
	This steering wheel's air bag is NOT affected, air bag removal for inspection is NOT necessary
GRUSBE519-07	Submit a claim for checking only.
	Optional Sports Steering Wheel Equipped Vehicles (with or without MFL button controls)
	This steering wheel's air bag MAYBE affected, remove, inspect and replace the air bag as necessary.
	Submit a claim for the inspection or the inspection/replacement repair that applies.
	Vehicles equipped with Optional Sports Steering Wheel only
	 Remove the driver's air bag in accordance with repair instructions REP 32 34 020 "Removing and installing/replacing air bag units".
	 Check the label on the back of the driver's air bag. Is the label yellow with a white number sticker with printed serial number BAM XXX - 1085 (as shown) printed below the bar code?
	YES - replace air bag following attached procedure.

Check the driver's air bag and if necessary, replace it.
