# SAFETY RECALL

**Mack Trucks**  
Greensboro, NC USA

Date	Number	Page
3/19	<b>SC0416</b>	1 (10)

## **Down View Mirror, Repair**

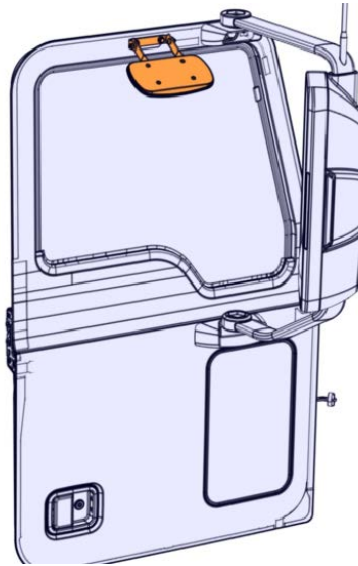
1. Identify the down view mirror.
