PRODUCT CAMPAIGN BULLETIN

APPLICABILITY: 2019MY Forester and Crosstrek Vehicles **NUMBER:** **WUC-88R**
SUBJECT: Power Steering Gear Box Inspect/Replacement **DATE:** 02/12/19
REVISED: 03/05/19
NHTSA ID: 19V-065

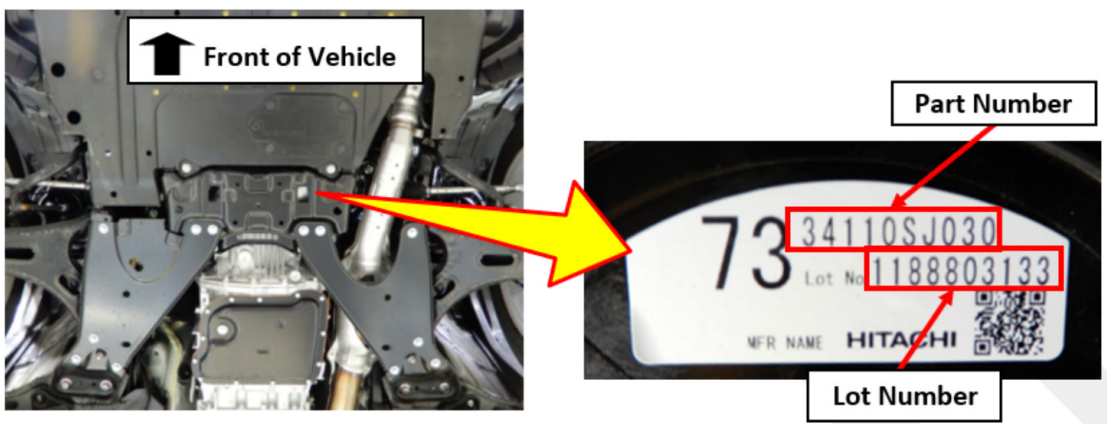
- 1) After confirming applicability, raise the vehicle on a lift.
- 2) The EPS Label and Lot Number are accessible through a hole in the crossmember support as shown.

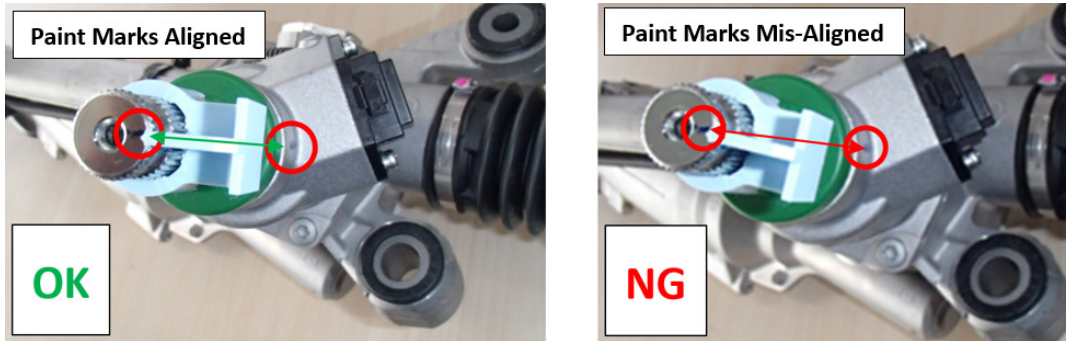
There is a VERY SMALL possibility the EPS gear box was not properly centered before the plastic retainer was installed during manufacturing. If this occurs:

- it may be difficult to match up the marks when re-connecting the EPS gear box to the steering shaft
- the number of turns between full steering lock left and right will be different
- one tie-rod boot will be collapsed (or extended) more than the other.

- If a **NG** condition is identified, please take a quality photo showing the mis-alignment and contact the Techline for further instruction.
 - Although the plastic retainer cap is white in the photos, it will likely be either green or blue depending on application.
5. When the Lot Number inspection procedure determines the EPS gear box assembly requires replacement, follow the procedure in the applicable Service Manual along with the Helpful Hints provided below. Pay close attention to the items listed as one-time-use. They are all supplied in the Hardware Kit and **MUST** be replaced during reassembly.
