March 2019
INT FL806-01/02
NHTSA #19V-066
Transport Canada #19-054
INTERIM RECALL BULLETIN
REVISED BULLETIN

Subject: Freightliner Cascadia Steering Wheel Airbags

Models Affected: Specific Freightliner Cascadia vehicles manufactured August 3, 2017, through January 30, 2019.

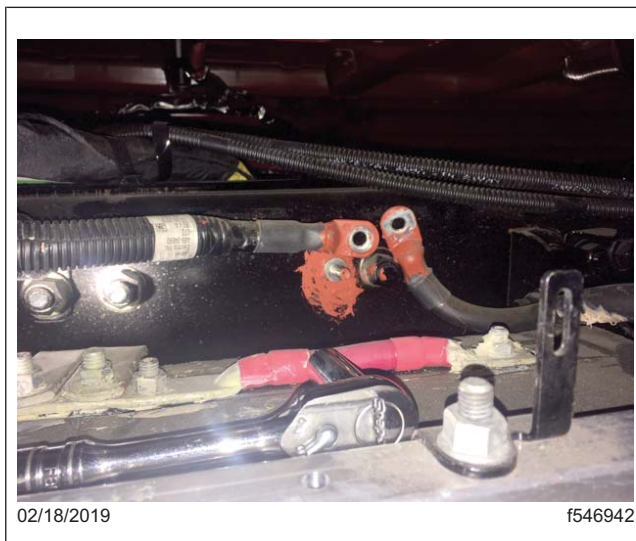
Fig. 1, GNDE Frame Rail Stud

6. Open the hood.
7. Inspect the vehicle frame rail GNDE and GNDP studs. See **Fig. 1** and **Fig. 2**. Use lacquer thinner, as needed, to clean off any excess paint on electrical connections throughout these instructions.

- Verify that the Electrical Ground (GNDE) and the Power Ground (GNDP) frame rail studs are clean and torqued correctly. Disassemble and inspect the studs for overspray on the flat surfaces, and in between the ring eyes. Torque these frame rail ground studs 14 lbf-ft (19 N·m). Repaint the connection as necessary.

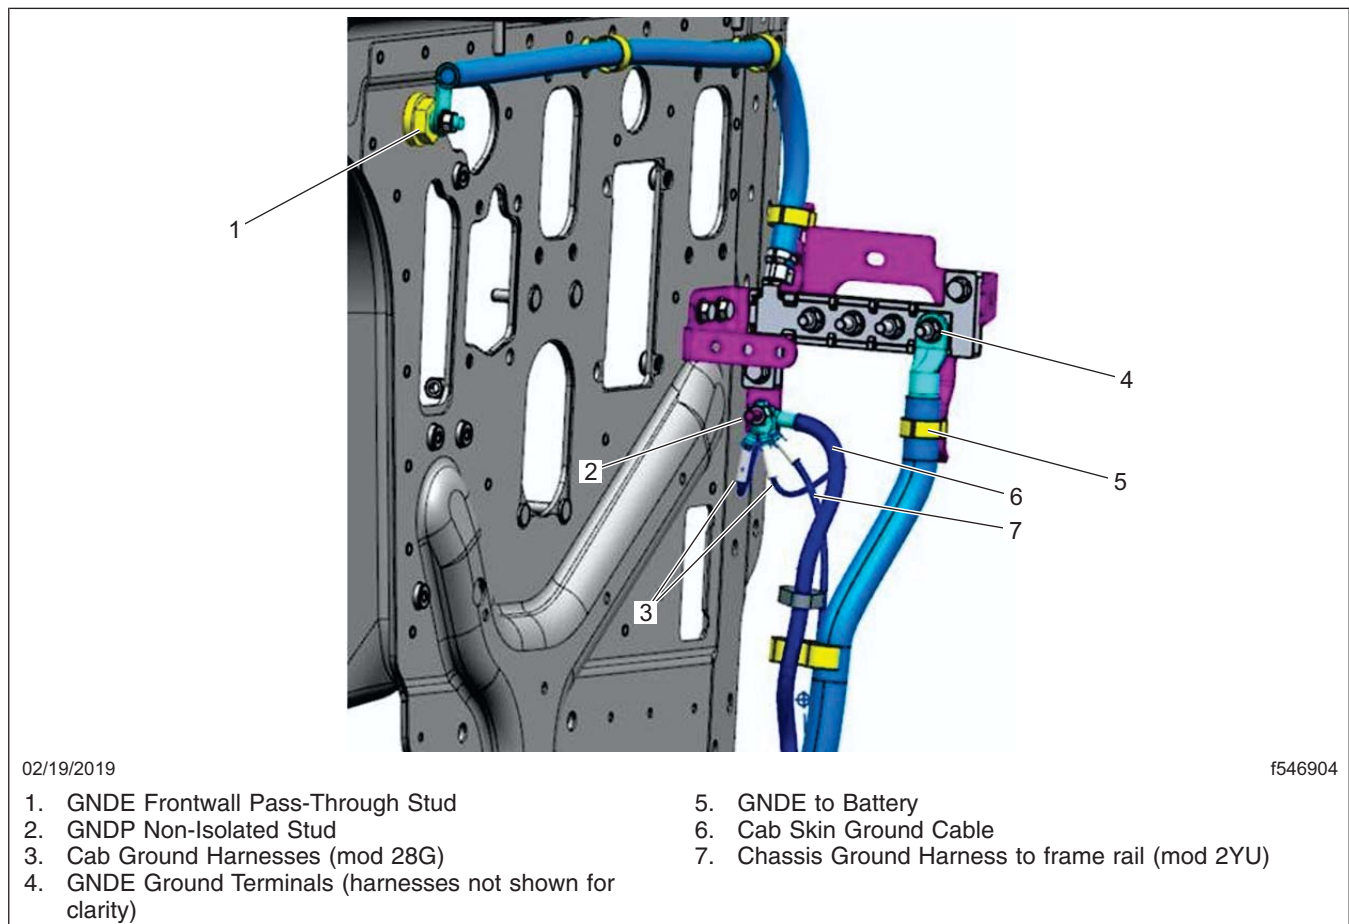
Fig. 3, MGJB and Frontwall Grounds

- Inspect the GNDP cab skin stud. See **Fig. 3** and **Fig. 4**. The left cab splash shield will need to be removed for this inspection. Verify that the GNDP skin stud on the underside of the cab is clean and torqued correctly. Do not over torque this stud. If the stud is stripped or spinning, in its mount, contact the district service manager for further instructions and include pictures. This skin stud is a critical grounding point for the cab. Disassemble and inspect the stud for overspray on the flat surfaces. Torque the stud 14 lbf-ft (19N·m). Repaint the connection as necessary.

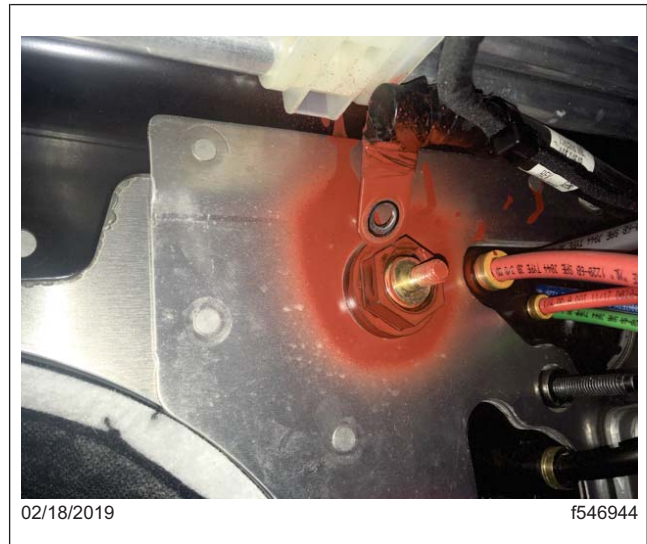
Fig. 5, GNDE Engine-Side Pass-Through Stud

- Inspect the GNDE pass-through stud on the engine side of the frontwall. See **Fig. 5** . Verify that the GNDE pass-through stud on the engine side frontwall is clean and torqued correctly. . Disassemble and inspect the stud for overspray on the flat surfaces. Torque the stud 14 lbf-ft (19 N·m). Repaint the connection as necessary.

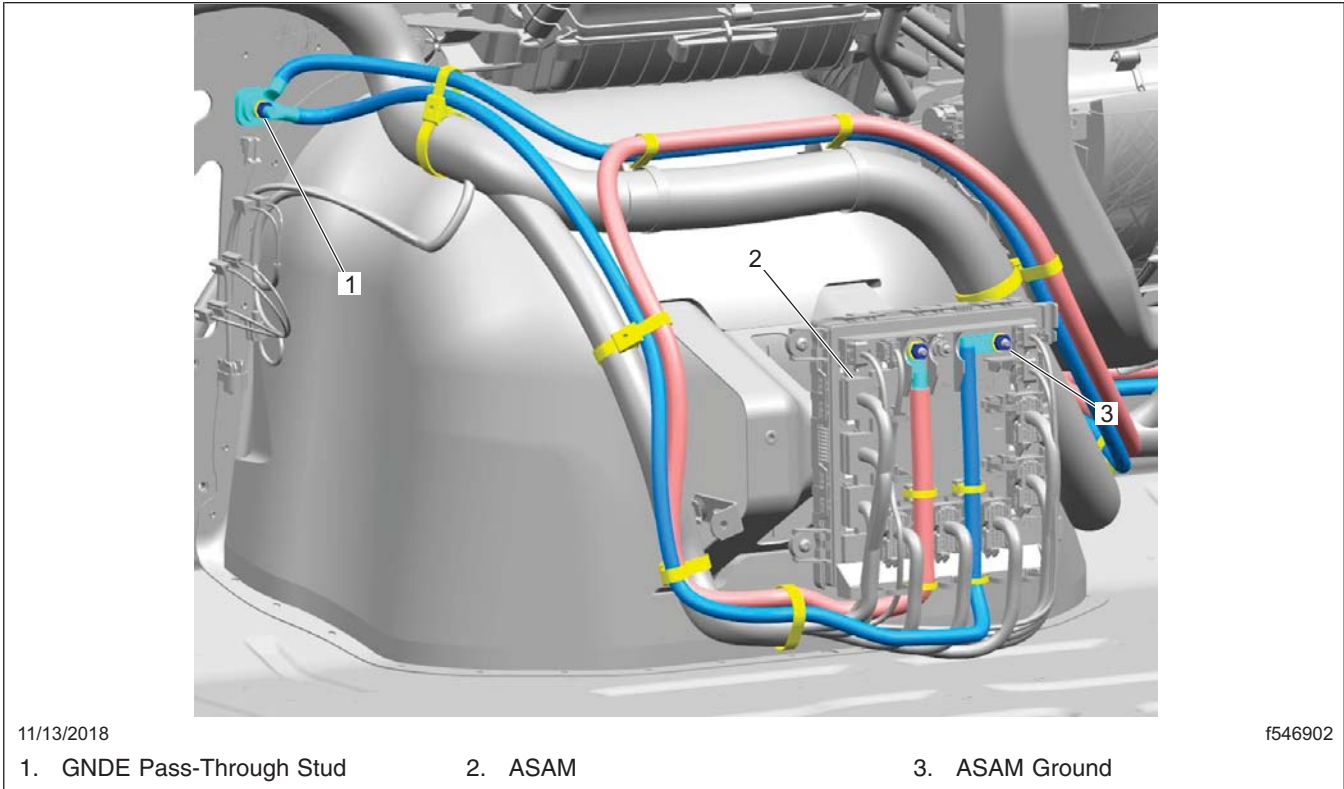
Fig. 6, Ground Locations Inside the Cab

14. Inspect the GNDE pass-through stud on the cab side of the frontwall. See [Fig. 6](#) and [Fig. 7](#). Wiggle the cable to check for movement, and service if loose. Torque the stud 14 lbf-ft (19 N·m).
