March 2019
INT FL806-01/02
NHTSA #19V-066
Transport Canada #19-054
INTERIM RECALL BULLETIN

Subject: Freightliner Cascadia Steering Wheel Airbags

Models Affected: Specific Freightliner Cascadia vehicles manufactured August 3, 2017, through January 30, 2019.

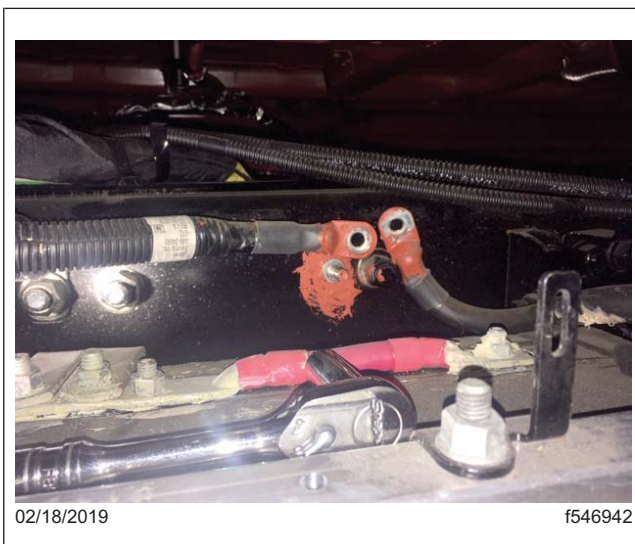
Fig. 1, GNDE Frame Rail Stud

On specific vehicles, an unintended deployment of the steering wheel airbag may occur under certain circumstances. The unintended deployment of a steering wheel airbag may be caused when certain electrical grounds are improperly assembled. This may cause risk of injury to the driver and potential increase in the risk of a crash.

6. Open the hood.
7. Inspect the vehicle frame rail GNDE and GNDP studs. See **Fig. 1** and **Fig. 2**. Use lacquer thinner, as needed, to clean off any excess paint on electrical connections throughout these instructions.

- Verify that the Electrical Ground (GNDE) and the Power Ground (GNDP) frame rail studs are clean and torqued correctly. Disassemble and inspect the studs for overspray on the flat surfaces, and in between the ring eyes. Torque these frame rail ground studs 14 lbf-ft (19 N-m). Repaint the connection as necessary.
