June 2019
FL806AB
NHTSA #19V-066
Transport Canada #19-054

Subject: Freightliner Cascadia Steering Wheel Airbags

Models Affected: Specific Freightliner Cascadia vehicles manufactured August 3, 2017, through January 30, 2019.

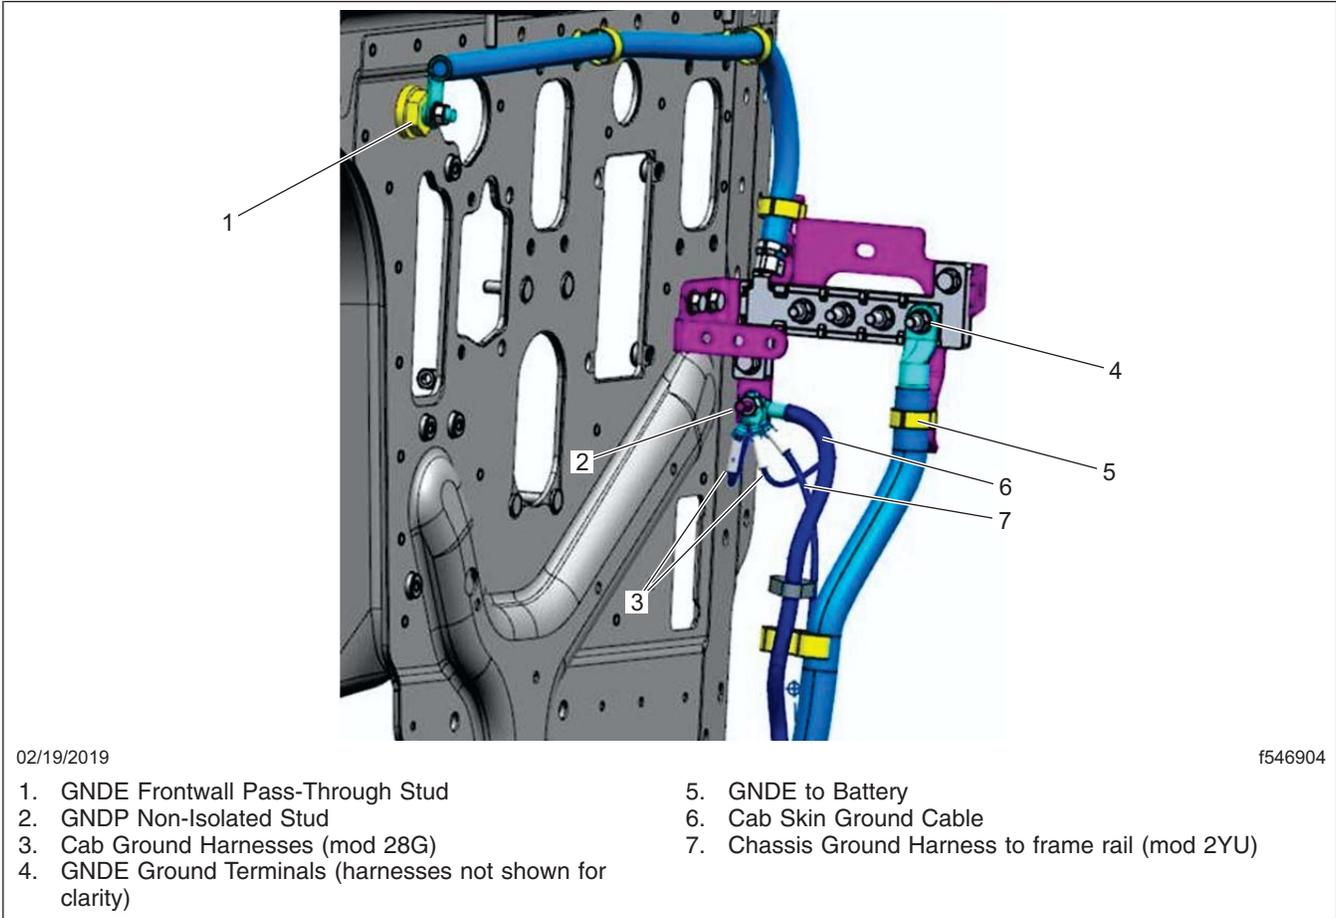
Fig. 6, MGJB and Frontwall Grounds

NOTE: There should always be FOUR ring eyes attached to the GNDP non-isolated stud. **The non-isolated stud itself is NOT a return path to ground through the bracket and relies on the grounding cable returning to the frame for ground;** confirm the 2YU GNDP cable is connected from the stud to the frame rail GNDP stud. The GNDP cab skin cable is oversized, and larger than the return to frame cable.

- 10.5 Use a cutoff wheel or suitable tool to cut the damaged stud off flush with lower floor skin.
- 10.6 Using a 5/16 x 1.25 bolt, install the A/C line support Z bracket, and secure it with a washer and nut. Torque to 14 lbf-ft (18 N·m).
- 10.7 Position the driver's-side floor mat in the vehicle and install the-driver's side lower steering cover, the lower A-pillar cover, and the sill cover.
11. Inspect the GNDE pass-through stud on the engine side of the frontwall. See [Fig. 6](#) and [Fig. 8](#). Verify that the GNDE pass-through stud on the engine side frontwall is clean and torqued correctly. Disassemble and inspect the stud for overspray on the flat surfaces. Torque the stud 7 lbf-ft (9.5 N·m). Repaint the connection as necessary.
12. Inspect the GNDP non-isolated stud, located on the lower aft portion of the MGJB bracket. See [Fig. 6](#), ref. 2.

Verify that the GNDP non-isolated stud is clean, configured properly, and torqued correctly. Disassemble and inspect the stud for overspray on the flat surfaces, and in between the ring eyes. Verify there are exactly four (4) circuits on ring eye terminals that attach to the GNDP non-isolated stud on every vehicle. If more or less are found on this stud, combine this inspection step with the next one for GNDE MGJB, separate and group the cables until four GNDP connections are confirmed. Fan these GNDP ring eyes properly on the non-isolated stud and then torque the stud to 14 lbf-ft (18 N·m). Repaint the connection as necessary.

13. Inspect the GNDE ring terminals on the isolated studs on the Main Ground Junction Block (MGJB). See [Fig. 6](#), ref. 4. Verify that the GNDE connections to the MGJB are clean, configured properly, and torqued correctly.

Disassemble and inspect the studs for overspray on the flat surfaces, and in between the ring eyes, then fan the ring eyes properly and torque the studs 14 lbf·ft (18 N·m). Repaint the connection as necessary.
