SI B63 02 19
Lights

RECALL CAMPAIGN 19V-074: REAR TAIL LIGHT

F48 (X1 SAV)

Produced from October 5th, 2018- January 18th, 2019.

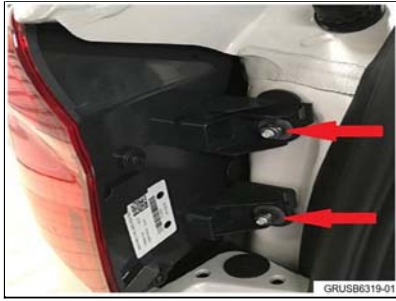
<ol style="list-style-type: none"> 1. Remove the water channel trim on both tail lights, following repair instructions REP 63 21 400 "Replace trim for water channel (left or right).

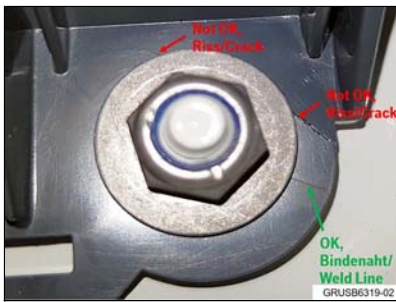
2. **Before** removing the tail light mounting nuts, carefully inspect the tail light mounting areas shown to the left for signs of cracking.

Note: Casting lines in the plastic as shown to the left are not a defect.

UPDATE! Ensure the tail lights are only replaced in case of cracking or oil contamination.

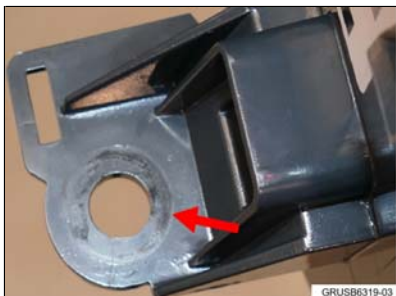
5. With the tail lights removed, re-inspect both sides of the tail light mounting tabs for signs of cracking.

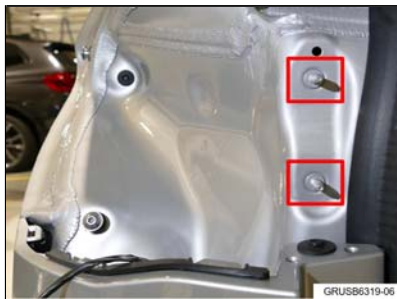
6. With the rear lights removed from the vehicle, the tail light mounting studs and vehicle body **MUST** be cleaned to remove potential residual manufacturing oil.

Using an 80% ethanol/20% water mixture on a clean cloth, clean the mounting studs and body area shown to the left.

Warning: 80% Ethanol/ 20% water is the only suitable cleaning solution that is safe for the vehicle body and tail lights. Do **NOT** use any alternative cleaning solution.
