SI B63 02 19
Lights

RECALL CAMPAIGN 19V-074: REAR TAIL LIGHT

F48 (X1 SAV)

Produced from October 5th, 2018- January 18th, 2019.

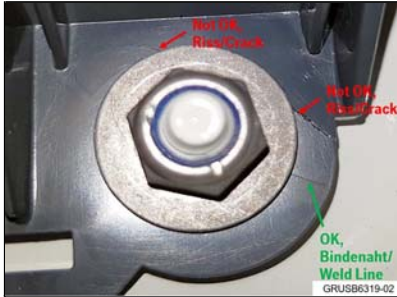
<p>GRUSB6319-02</p>	<p>

<p>GRUSB6319-01</p>	<p>“Replace trim for water channel (left or right).</p> <p>2. Before removing the tail light mounting nuts, carefully inspect the tail light mounting areas shown to the left for signs of cracking.</p>

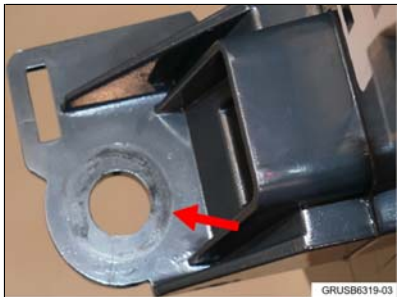
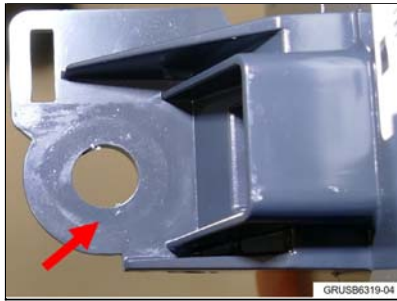
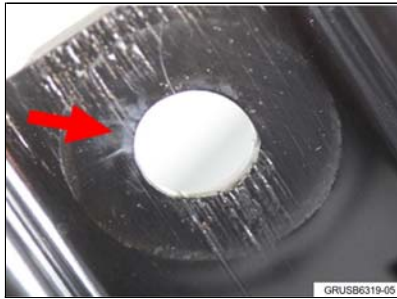
<p>GRUSB6319-03</p>	<p>5. With the tail lights removed, re-inspect both sides of the tail light mounting tabs for signs of cracking.</p> <p>Inspect the mounting tabs of the tail lights for signs of oil residue. Examples of oil residue on the mounting tabs can be seen to the left. All 3 photos</p>

to the left show indications of oil residue and are **NOT OK.**

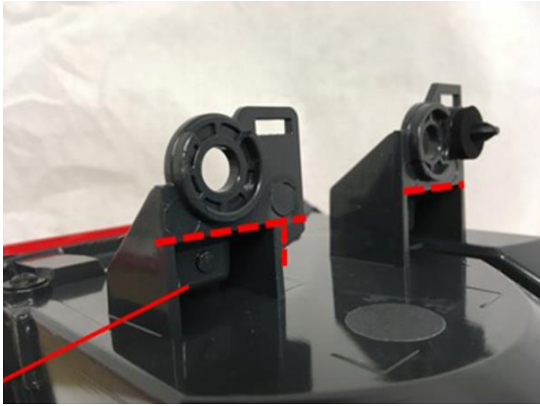
1. Ensure that the damage does not extend beyond the dotted lines shown below. If cracking extends closer to the tail light housing than the dotted line, or if the mounting tab is completely broken off of the tail light housing beyond the dotted line, the tail light will require replacement following the instructions within the SI B.
