SIB 63 02 19

RECALL CAMPAIGN 19V-074: REAR TAIL LIGHT

F48 (X1 SAV)

Produced from October 5th, 2018- January 18th, 2019.

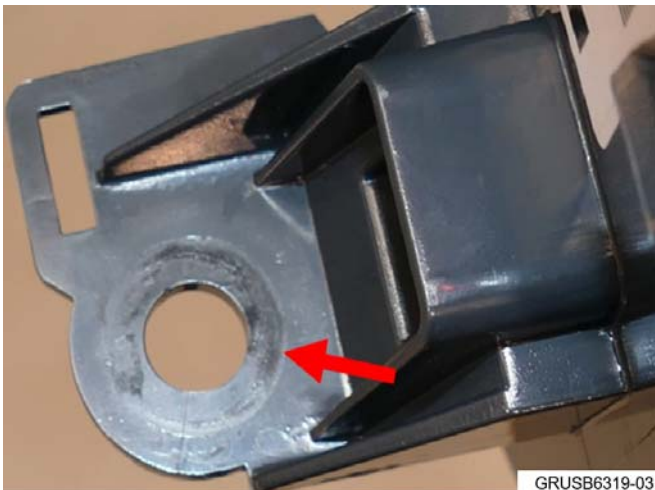
GRUSB6319-03

4. Immediately secure the tail light mounting nuts so that they cannot be reused.
