# Product Safety Recall

## N182204190 Chassis Cab Truck Fuel Leak

**Release Date:** September 2019

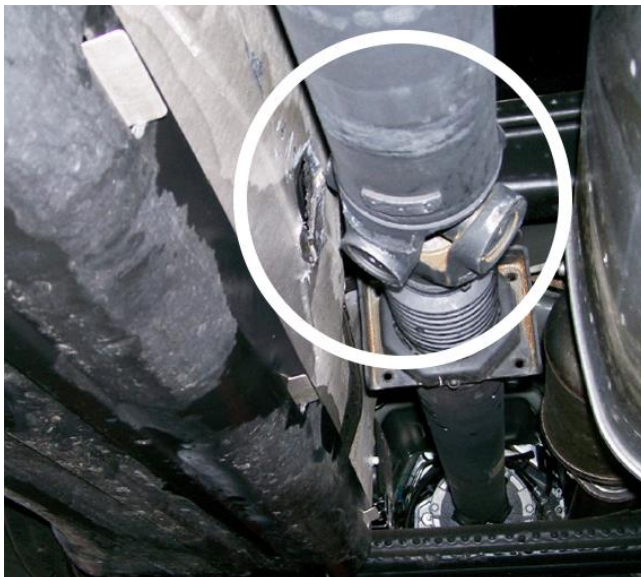
4916360

2. Inspect the front fuel tank shield for contact with the propeller shaft universal joint, as shown above.
  - If there is evidence of the propeller shaft universal joint contacting the shield, proceed to the next step
  - If there has not been any contact, proceed directly to step 7.
3. Remove the fuel tank shield. Refer to *Fuel Tank Shield Replacement* in SI.
4. Inspect the front fuel tank for evidence of the propeller shaft universal joint contact.

- If there is NO evidence of the propeller shaft universal joint contacting the front fuel tank, proceed to the next step.
  - If there is evidence of the propeller shaft universal joint contacting the front fuel tank, replace the front fuel tank. Refer to *Fuel Tank Replacement (Cab/Chassis – Front)*.
5. Replace the front fuel tank fuel level sensor. Refer to *Fuel Level Sensor Replacement (25/35 Series)*.
  6. Replace the fuel tank shield. Refer to *Fuel Tank Shield Replacement* in SI.
  7. Reprogram the Engine Control Module. Refer to *K20 Engine Control Module: Programming and Setup* in SI.

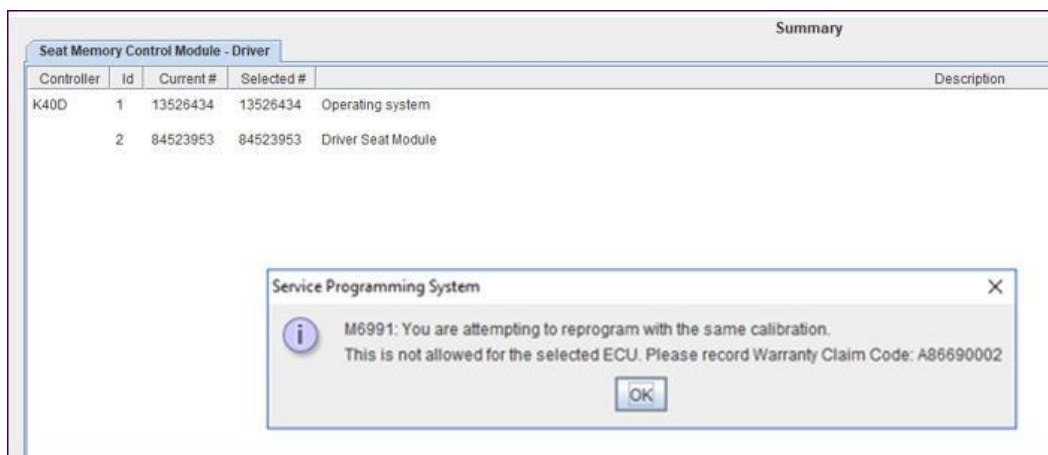
5164840

**Note:** If the Same Calibration/Software Warning is noted on the SPS Summary screen, record the warranty claim code (WCC) and select OK and follow screen instructions. After a successful programming event, the WCC is located in the Service Programming System dialogue box of the SPS Summary screen. No further action is required. Refer to the Warranty section of the bulletin.

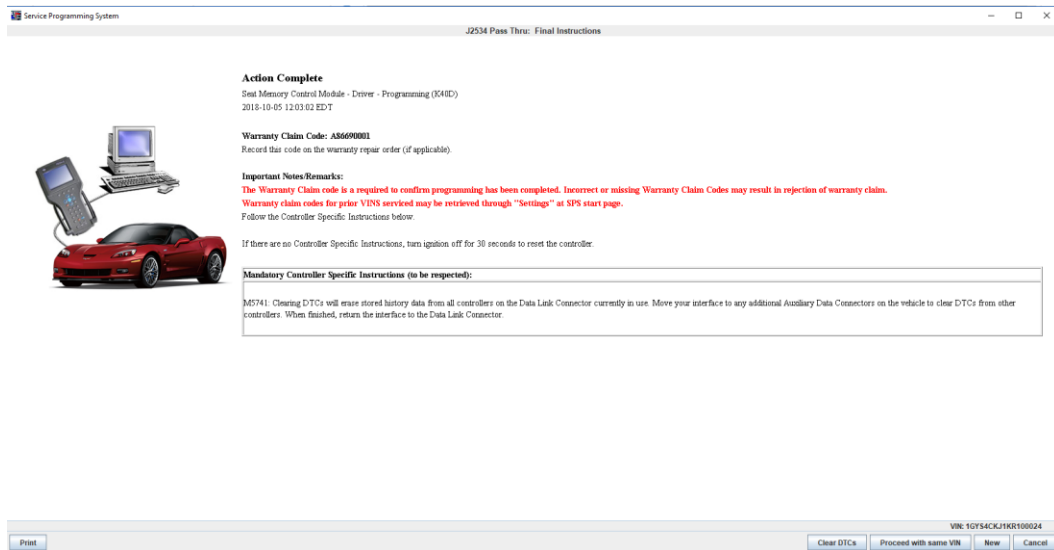
5164843

8. Record SPS Warranty Claim Code on job card for warranty transaction submission.
