Product Safety Recall

N182204190 Chassis Cab Truck Fuel Leak

Release Date: July 2019

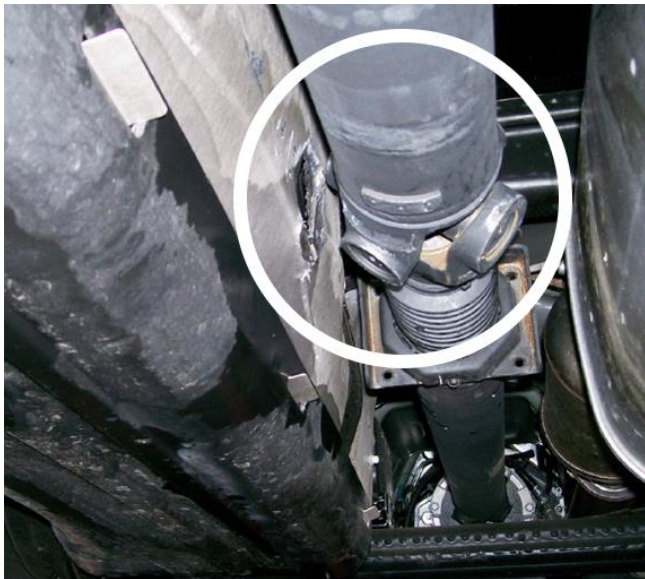
4916360

2. Inspect the front fuel tank shield for contact with the propeller shaft universal joint, as shown above.
 - If there is evidence of the propeller shaft universal joint contacting the shield, proceed to the next step.

- If there has not been any contact, proceed directly to step 7.
3. Remove the fuel tank shield. Refer to *Fuel Tank Shield Replacement* in SI.
4. Inspect the front fuel tank for evidence of the propeller shaft universal joint contact.

- If there is NO evidence of the propeller shaft universal joint contacting the front fuel tank, proceed to the next step.
 - If there is evidence of the propeller shaft universal joint contacting the front fuel tank, replace the front fuel tank. Refer to *Fuel Tank Replacement (Cab/Chassis – Front)*.
