# Product Safety Recall

## N182204190 Chassis Cab Truck Fuel Leak

**Release Date:** September 2019

**Revision:** 02

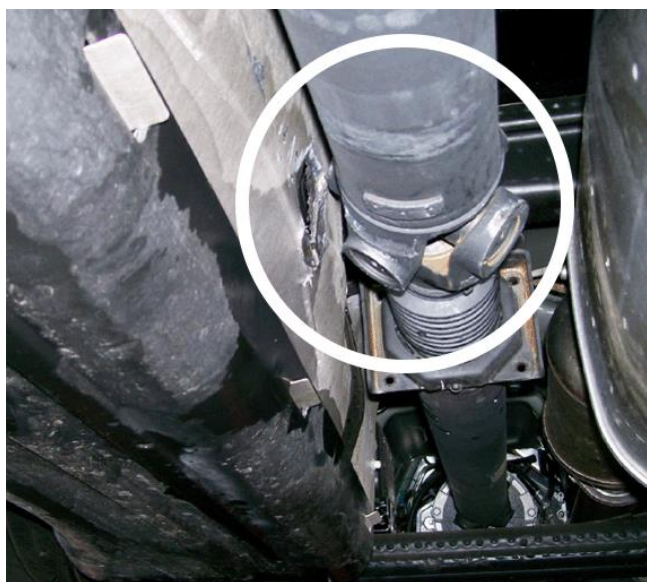
4916360

2. Inspect the front fuel tank shield for contact with the propeller shaft universal joint, as shown above.
  - If there is evidence of the propeller shaft universal joint contacting the shield, proceed to the next step

- If there has not been any contact, proceed directly to step 7.
3. Remove the fuel tank shield. Refer to *Fuel Tank Shield Replacement* in SI.
  4. Inspect the front fuel tank for evidence of the propeller shaft universal joint contact.

- If there is NO evidence of the propeller shaft universal joint contacting the front fuel tank, proceed to the next step.
    - If there is evidence of the propeller shaft universal joint contacting the front fuel tank, replace the front fuel tank. Refer to *Fuel Tank Replacement (Cab/Chassis – Front)*.

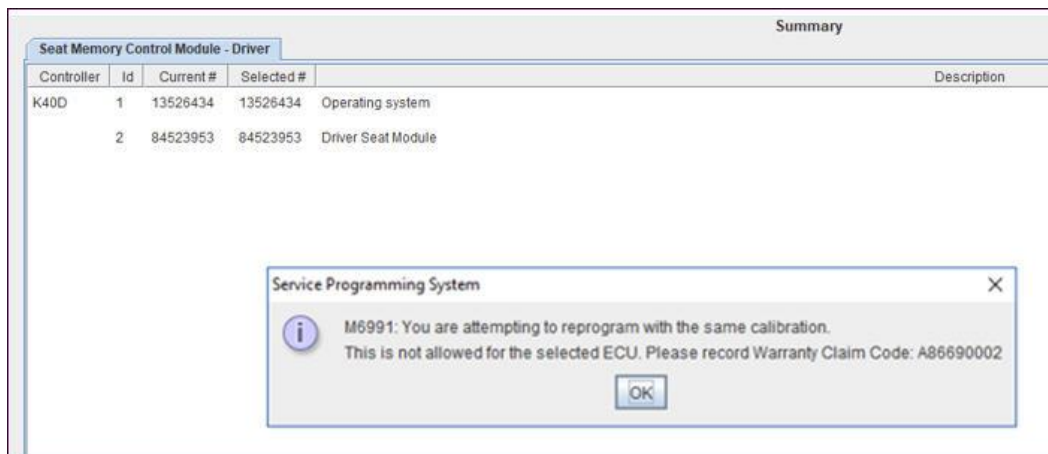
5164840

**Note:** If the Same Calibration/Software Warning is noted on the SPS Summary screen, record the warranty claim code (WCC) and select OK and follow screen instructions. After a successful programming event, the WCC is located in the Service Programming System dialogue box of the SPS Summary screen. No further action is required. Refer to the Warranty section of the bulletin.
