# Ferrari North America, Inc.

U.S.A. RECALL CAMPAIGN NO. C24000067

# LH And RH Bowden Cable Replacement And Layout Review

**SUBJECT:** Recall Campaign No. C24000067

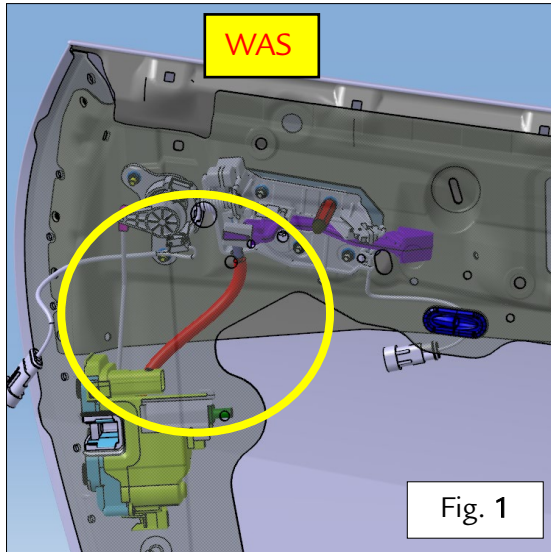
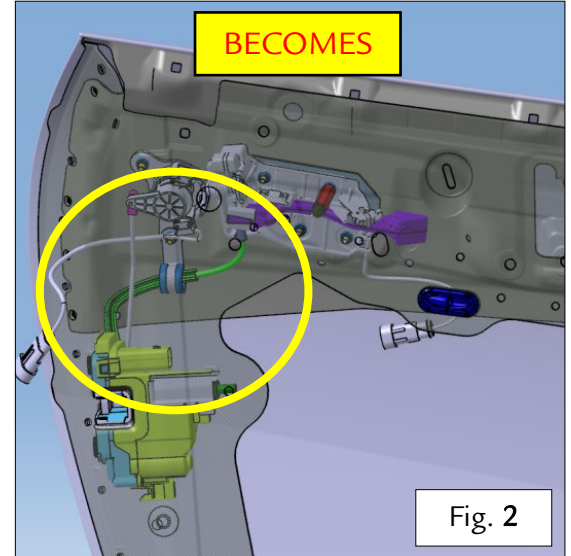
The repair, which applies to both the driver side and the passenger side doors, involves (Fig. 1 and 2):

- Replacing the cable with a longer one (50 mm longer);
- Making the cable layout fool proof with a bracket fastened to the pawl housing;
- Replacing the door lock

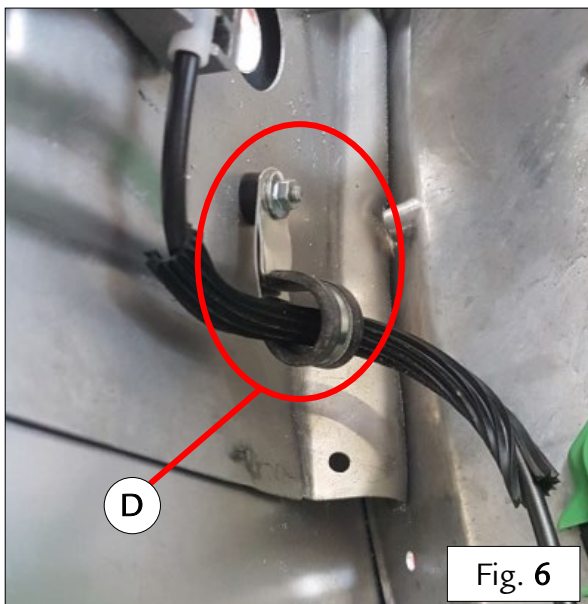
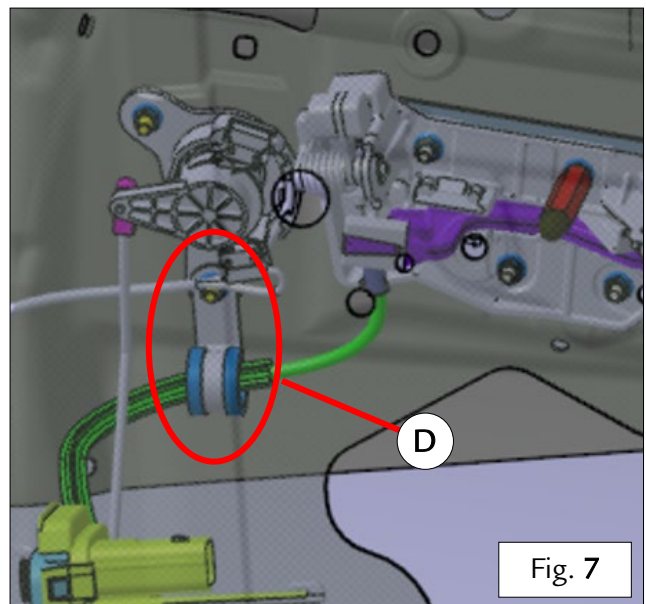
**Note:** Note that, in order to show the correct position of the bracket, the pawl housing is not shown in Figures 6 and 8.

4. Using the existing fastening for the pawl housing, fit the bracket (D), and tighten the nut to a torque of 2 Nm, class B - (Fig. 6 and 7).
