Vehicle Safety Recall - Technical Service Bulletin

Attention: McNeilus Product Owner
Subject: Clearance Lamp Wiring Update
Models Affected: Oshkosh S-Series Front Discharge Mixer
Model Year: 2014-2019
Date: April 2019

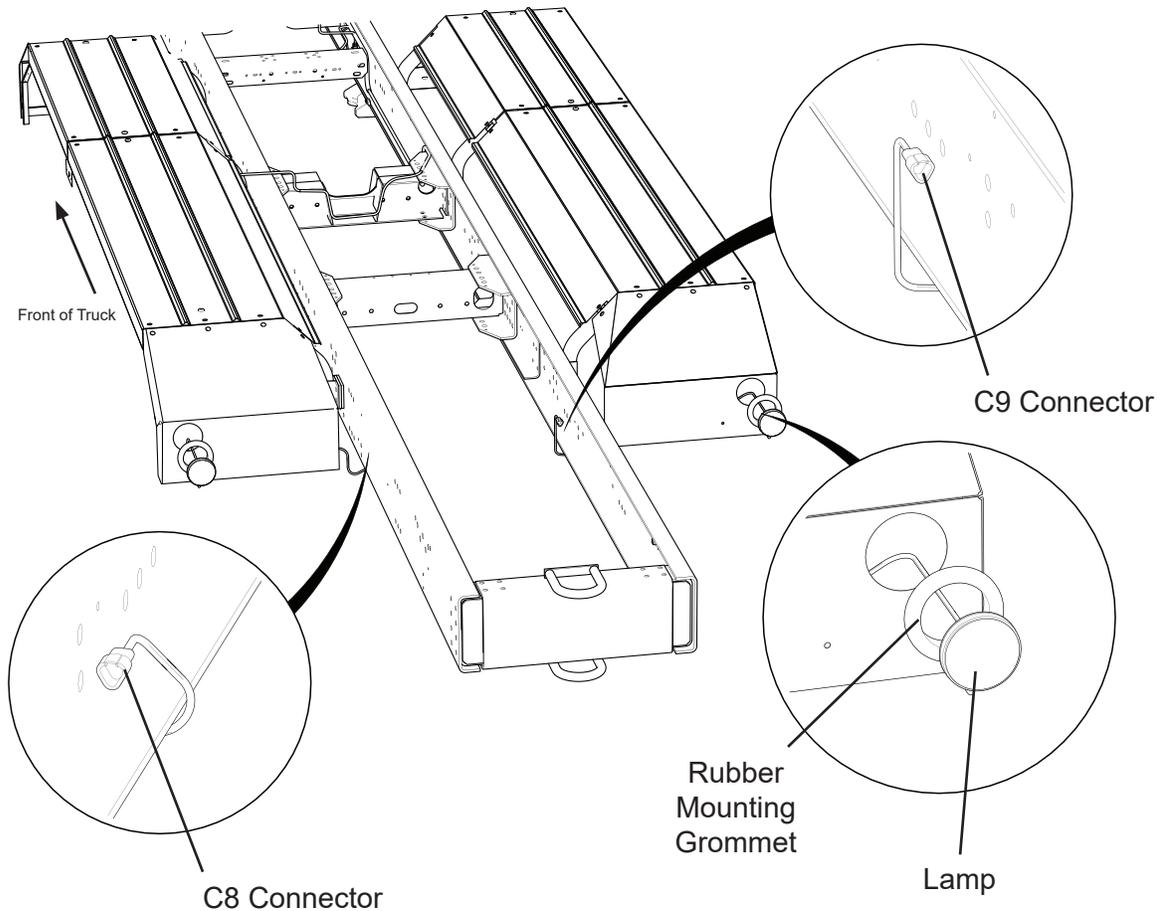
Figure 1. Fender Rear Clearance Lamp

McNeilus Truck and Manufacturing, Inc. has decided that a concern affecting safety exists in some McNeilus/Oshkosh S-Series Front Discharge Mixers. Trucks have been identified that are equipped with an optional strobe lamp that may be the wrong color and wired incorrectly. The wiring may allow the clearance lamps to flash, which is noncompliant to Federal Motor Vehicle Safety Standards that require steady burning red lamps. This bulletin provides instructions on how to replace the amber lamps and update the wiring to have to the clearance lamps function as steady burning lamps as required by federal regulations.

1. Remove the rubber mounting grommet and amber marker lamp from the rear of the right-hand fender assembly. See Figure 1.
2. Disconnect the harness plug from the back of the amber lamp.
3. Separate the amber lamp from the rubber mounting grommet. Discard the amber lamp.
4. Install red lamp (PN 3551395) into the rubber mounting grommet.
5. Connect the wire harness plug to the back of the red lamp.
6. Install the rubber mounting grommet and red lamp into the right-hand fender assembly.
7. Locate connector C9 along the right-hand frame rail. See Figure 1. Cut zip ties that secure the harness and plug.
8. Unplug the C9 connector.

14. Reconnect connector C9. Zip tie connector and harness into original position along the frame rail.
15. Remove the rubber mounting grommet and amber marker lamp from the rear of the left-hand fender assembly. See Figure 1.

16. Disconnect the harness plug from the back of the amber lamp.
17. Separate the amber lamp from the rubber mounting grommet. Discard the amber lamp.
18. Install red lamp (PN 3551395) into the rubber mounting grommet.

19. Connect the wire harness plug to the back of the red lamp.
20. Install the rubber mounting grommet and red lamp into the left-hand fender assembly.
21. Locate connector C8 along the left-hand frame rail. See Figure 1. Cut zip ties that secure the harness and plug.
