April 2019
FL807A-E
NHTSA #19V-093
Transport Canada #2019-066
REVISED NOTICE

Subject: Hendrickson 5 Inch Drop Axle Tie Rods

Models Affected: Specific Freightliner Cascadia vehicles manufactured April 30, 2012, through May 26, 2015, equipped with Hendrickson 5 inch drop axle tie rods, brake linings, and stamped spiders.

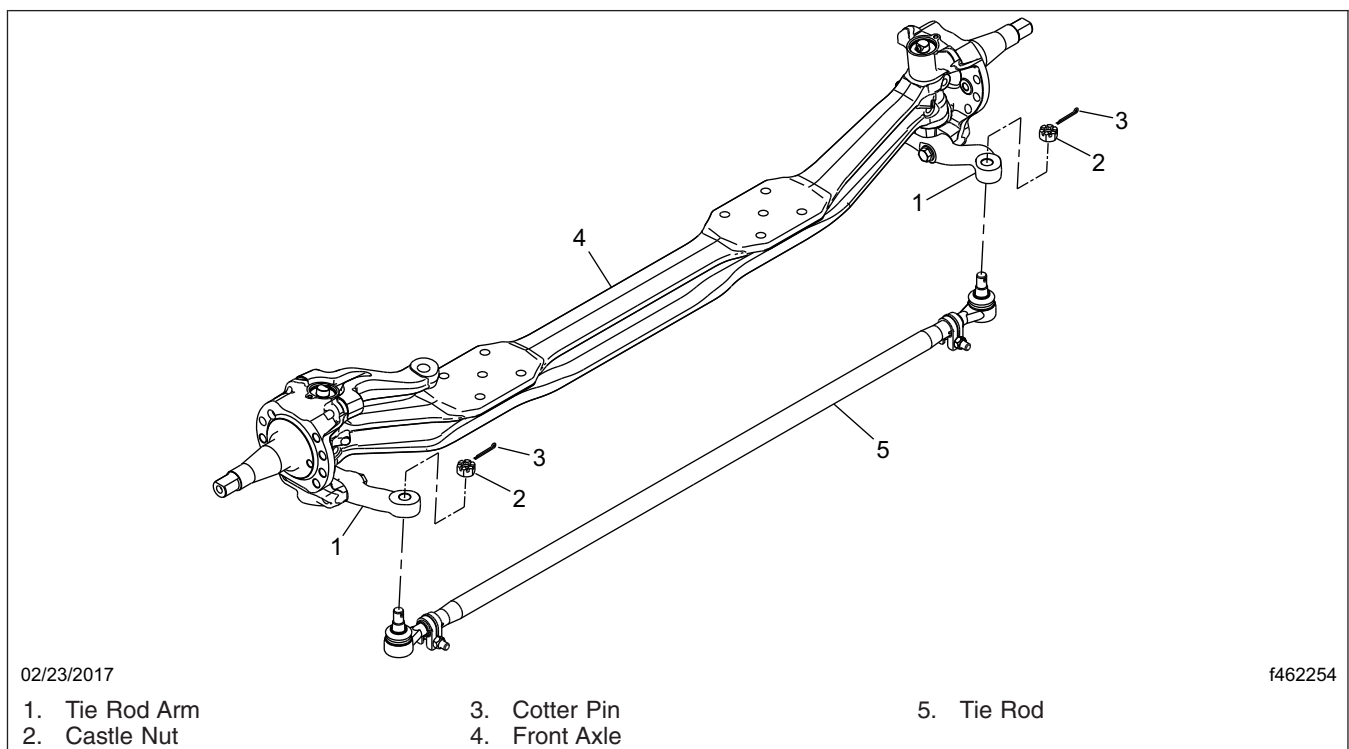
In certain circumstances, high brake vibrations may occur due to a specific combination of Hendrickson 5 inch drop axle tie rods, brake linings, and stamped spiders. These vibrations may lead to a reduced fatigue life and early separation of the tie rod. Separation of the tie rod may lead to a disconnect between the front wheels of the vehicle and reduce the ability to steer the vehicle, which could increase the risk of a crash.

6. Remove the brake assembly. Refer to the applicable section in **Group 42** of the *Cascadia Workshop Manual*.
7. Disconnect the tie rod from the tie rod arms; see [Fig. 1](#). Remove the tie rod from the vehicle and discard it.

8. Attach a new tie rod to the tie rod arms. Tighten the castle nut 120 to 170 lbf-ft (163 to 230 N·m) plus a maximum of one-sixth of a turn to align a slot in the castle nut with the cotter pin hole in the tie rod stud. Insert the cotter pin and bend the tangs to secure it.
9. Clean and inspect all brake parts that will be reused. Refer to the applicable section in **Group 42** of the *Cascadia Workshop Manual*.
