GROUP Safety Recall Campaign	MODEL 2012-2016MY Soul (AM, PS)
	NUMBER SC176	DATE April 2019
SAFETY RECALL CAMPAIGN		
SUBJECT: ENGINE CONTROL UNIT (ECU) LOGIC IMPROVEMENT (SC176)

This bulletin provides the procedure to upgrade the Catalyst Overheating Protection (COP) logic in the Engine Control Unit (ECU) and, if necessary, replace the Catalytic Converter on some 2012 ~ 2016 MY Soul (AM/PS) vehicles, produced from July 8, 2011 through August 11, 2016. Depending on the extent of damage, the short block assembly may also need to be replaced. The affected vehicles may exhibit catalyst system efficiency deterioration or a malfunction indicator lamp illumination with DTC P0420 (Catalyst System Efficiency Below Threshold Bank 1). Under certain conditions, the catalytic converter may become damaged due to overheating caused by an excessive increase of exhaust gas temperatures. If the catalytic converter is damaged, substrate particles can enter the engine combustion chamber and cause abnormal engine combustion. Continuous abnormal engine combustion can result in damage to one or more of the engine's pistons which can cause piston rod breakage, potentially puncturing the engine block allow

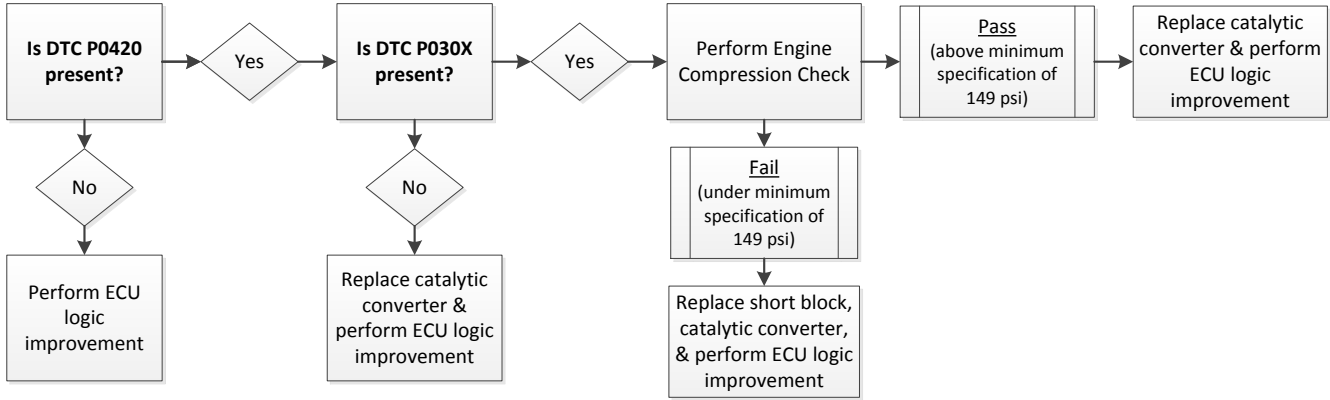
Flow Chart:

- Using the KDS (connected to the internet to create and transmit a VDN*), perform a Fault Code Search and confirm DTC P0420 or both P0420 and P030X is/are present. Follow the flow chart below and perform the necessary procedure(s).
