GROUP
Safety Recall Campaign

MODEL
2012-2016MY
Soul (AM, PS)

NUMBER
SC176 (Rev 3, 07/30/2019)

SUBJECT: ENGINE CONTROL UNIT (ECU)
LOGIC IMPROVEMENT (SC176)

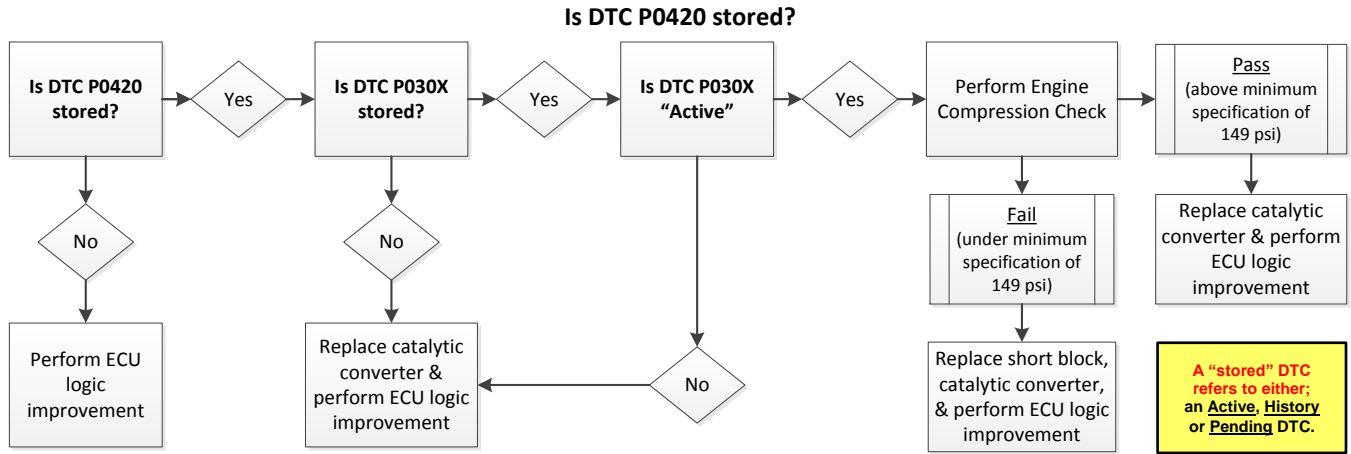
Flow Chart:

- Using the KDS (connected to the internet to create and transmit a VDN*), perform a Fault Code Search and confirm DTC P0420 or both P0420 and P030X is/are **stored (Active, History or Pending)**. Follow the flow chart below and perform the necessary procedure(s).
 *A Vehicle Diagnosis Number (VDN) must be created with DTC P0420 or P0420 and P030X, prior to ordering select parts and performing necessary procedure(s) according to flow chart. If a VDN is not created, Parts order entry or Warranty claim submission issues may occur.

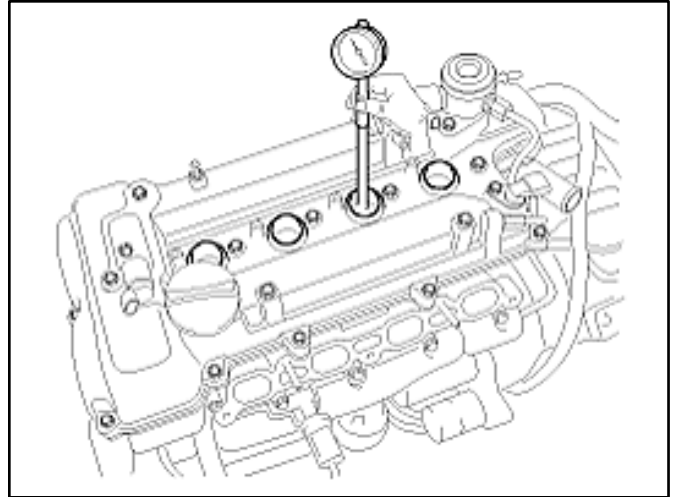
- Coolant at operating temp (176°F)
- Battery fully charged
- If all cylinder compression results* are above the minimum specification, proceed to the Catalytic Converter Assembly Replacement Procedure below.
- If any cylinder compression result* is below the minimum specification, proceed to the Short Block Assembly Replacement Procedure on page 10.

Standard	178 PSI, 1225.83 KPa, 12.5 kg.cm ²
Minimum	149 PSI, 1029.69 KPa, 10.5 kg.cm ²

1. Ensure all conditions are met and then perform an engine compression check by referring to the “Engine Mechanical System → Compression Test” chapter in the applicable Shop Manual on KGIS.
