GROUP
Safety Recall Campaign

MODEL
2012-2016MY
Soul (AM, PS)

NUMBER
SC176 (Rev 1, 05/22/2019)

SUBJECT: ENGINE CONTROL UNIT (ECU)
LOGIC IMPROVEMENT (SC176)

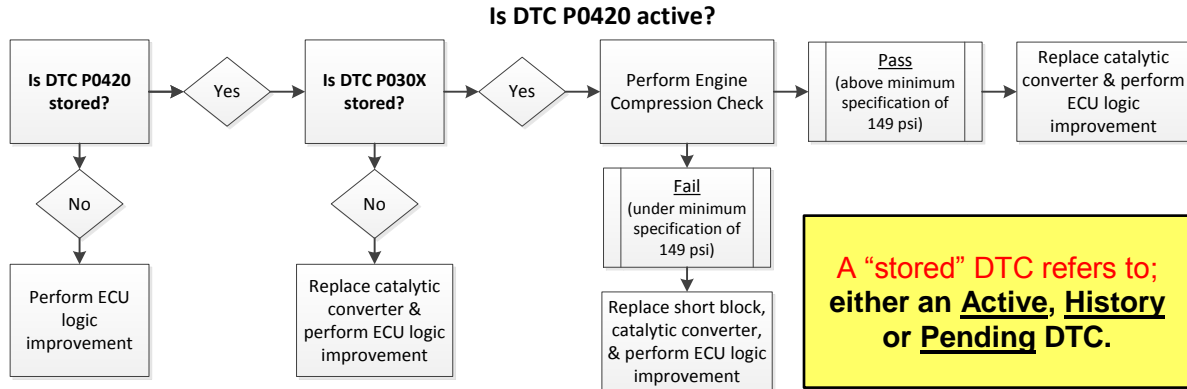
Flow Chart:

- Using the KDS (connected to the internet to create and transmit a VDN*), perform a Fault Code Search and confirm DTC P0420 or both P0420 and P030X is/are **stored (Active, History or Pending)**. Follow the flow chart below and perform the necessary procedure(s).
 *A Vehicle Diagnosis Number (VDN) must be created with DTC P0420 or P0420 and P030X, prior to ordering select parts and performing necessary procedure(s) according to flow chart. If a VDN is not created, Parts order entry or Warranty claim submission issues may occur.

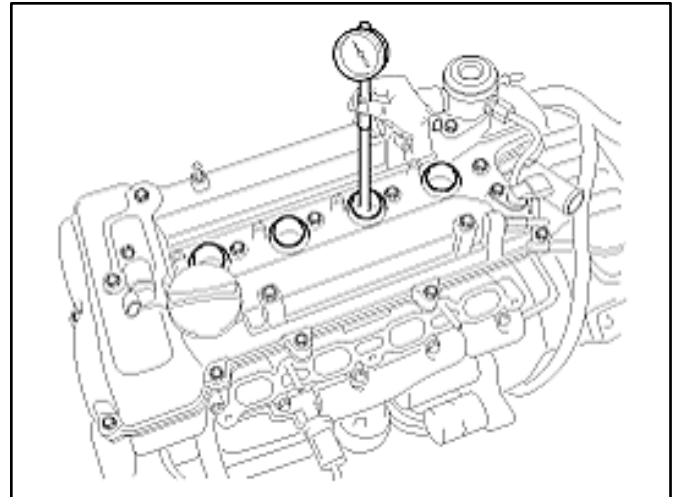
- Coolant at operating temp (176°F)
- Battery fully charged
- If all cylinder compression results* are above the minimum specification, proceed to the Catalytic Converter Assembly Replacement Procedure below.
- If any cylinder compression result* is below the minimum specification, proceed to the Short Block Assembly Replacement Procedure on page 10.

Standard	178 PSI, 1225.83 KPa, 12.5 kg.cm ²
Minimum	149 PSI, 1029.69 KPa, 10.5 kg.cm ²

1. Ensure all conditions are met and then perform an engine compression check by referring to the “Engine Mechanical System → Compression Test” chapter in the applicable Shop Manual on KGIS.
