Recall Campaign Bulletin

Campaign No. 2018040007, June 2018 REV C June 2019

SUBJECT: Models 205 and 238 Model Years 2017 and 2018

Check Seat Back Lock

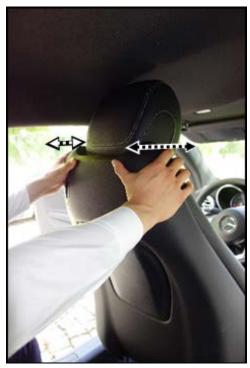
Figure 1 (left front seat)

- i The play must be the **same** on both the right and left sides.
 - i If the play is not correct, the <u>right</u> side of the seat backrest has a <u>significantly larger amount of play</u> than the left (figures 1 and 2)!

- a. Play of the seat backrest frame not ok: Carry out work procedure.
- b. Play of the seat backrest frame is ok: End measure.
