TO: Mercedes-Benz Dealer Principals, General Managers, Sales Managers, Service Managers, Parts Managers	FROM: Gregory Gunther, Department Manager, Vehicle Compliance and Analysis, Engineering Services
RE: Recall Campaign Launch Notification Rework Rear Tail Lamp MY18 117 (CLA-Class)	DATE: March 29, 2019

Campaign No. 2019030009, March 2019

SUBJECT: **Model CLA-Class vehicles (117 platform)**
Model Year 2018
Rework Rear Tail Lamp

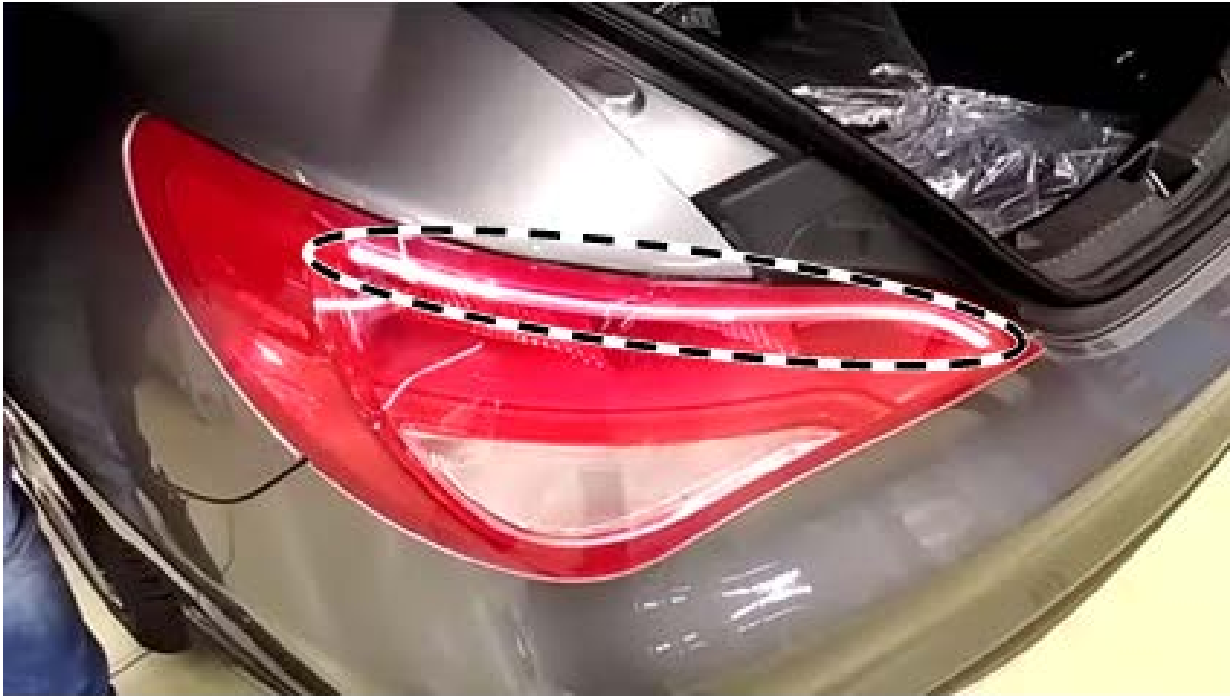
Figure 1

1. Check standing lights/parking lights (**Figure 1**) of *right* and *left* tail lamps for proper operation (AP82.10-P-8252EW).

i The standing lights/parking lights of the tail lamp must **not** flicker or fail.

- a. If the standing lights/parking lights of the tail lamp **flicker** or **fail**: Carry out **work procedure**.
- b. If the side marker lamp in **U.S.A./Canada** vehicles **flickers** or **fails**: Carry out **work procedure**.
- c. If the standing lights/parking lights of the tail lamp **light up**: **End measure**.
- d. If the side marker lamp in **U.S.A./Canada** vehicles **lights up**: **End measure**.
