Dealer Service Instructions for:

Safety Recall V15 / NHTSA 19V-143

Ball Joint

2018 (RU) Chrysler Pacifica

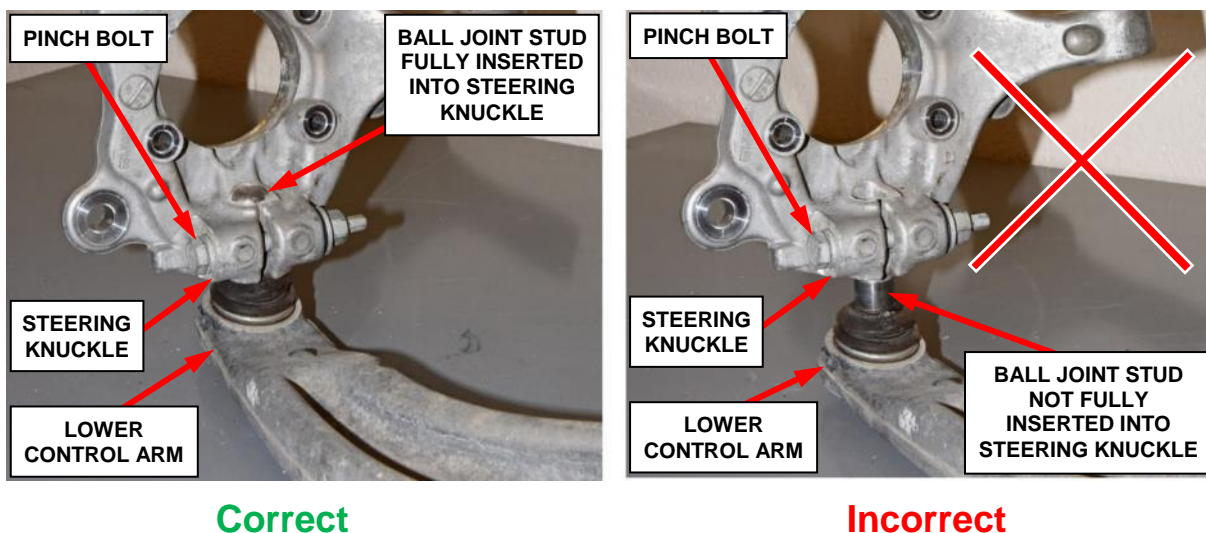
Figure 1 – Lower Control Arm Ball Joint Stud Insertion into Steering Knuckle

1. Raise and support the vehicle.
2. Remove the right front tire and wheel assembly.
3. Inspect the right side lower control arm ball joint stud insertion into the steering knuckle. The ball joint stud should be fully inserted into the steering knuckle. The pinch bolt should be securely tight with no observable movement of the pinch bolt and no observable movement of ball joint stud in the steering knuckle (Figure 1).

4. Is the ball joint stud fully inserted into the steering knuckle?
 - **YES:** The ball joint stud is fully inserted. Continue with **Step 5**.
 - **NO:** Proceed to **Section B. Replace Lower Control Arm and Knuckle**.
5. Is the ball joint stud and pinch bolt securely tight?
 - **YES:** Ball stud and pinch bolt are securely tight. Continue with **Step 6**.
 - **NO:** Proceed to **Section B. Replace Lower Control Arm and Knuckle**.

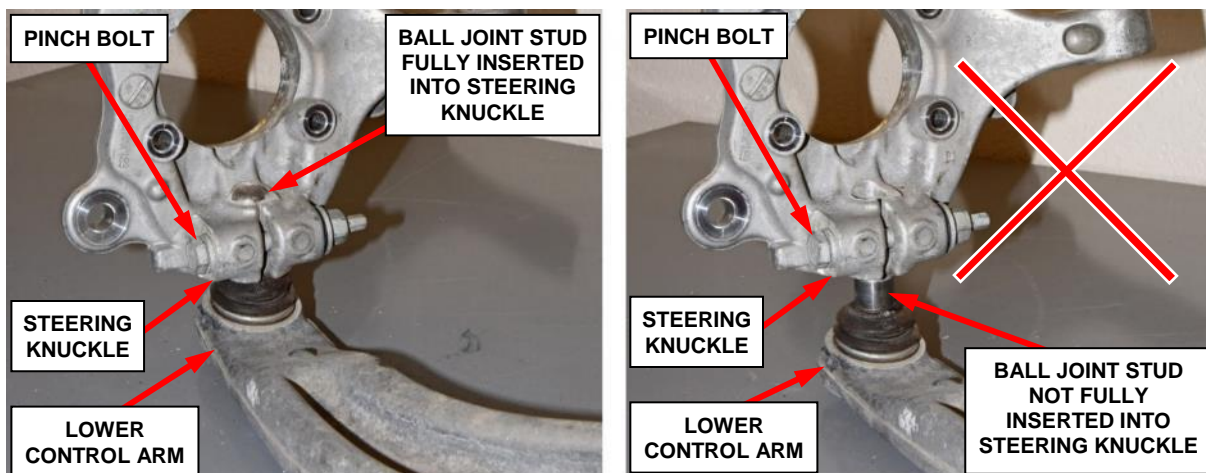
Figure 16 – Lower Control Arm Ball Joint Stud Insertion into Steering Knuckle

WARNING: Make sure lower control arm ball joint stud is fully inserted into knuckle before pinch bolt is inserted into knuckle. Only ball joint stud rubber boot should be visible below the knuckle; stud should not be visible (Figure 16). Failure to fully and properly insert ball joint stud could lead to wheel separation and loss of mobility and could result in personal injury or death.

32. Install the NEW steering knuckle onto the lower ball joint stud and verify it is in the correct position with the ball joint stud visible at the upper portion of the mounting hole before installing the NEW pinch bolt (Figure 16).
