PRODUCT CAMPAIGN BULLETIN

APPLICABILITY: 2013-2017 Crosstrek
 2014-2016 Forester
 2008-2016 Impreza 4-door
 2012-2016 Impreza 5-door
 2008-2014 WRX 4-door

NUMBER: WUE-90R
NHTSA ID: 19V-149
DATE: 04/09/19
REVISED: 05/08/19

SUBJECT: Brake Lamp Switch Replacement

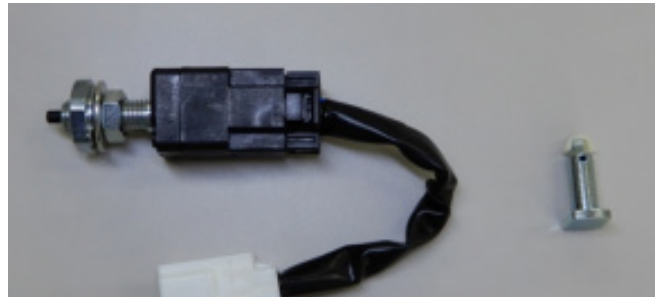
A Brake Lamp Switch Repair Kit has been established. The part number is **83319FJ000**. The kit includes:

- Brake Lamp Switch
- Adapter Harness
- Clevis Pin

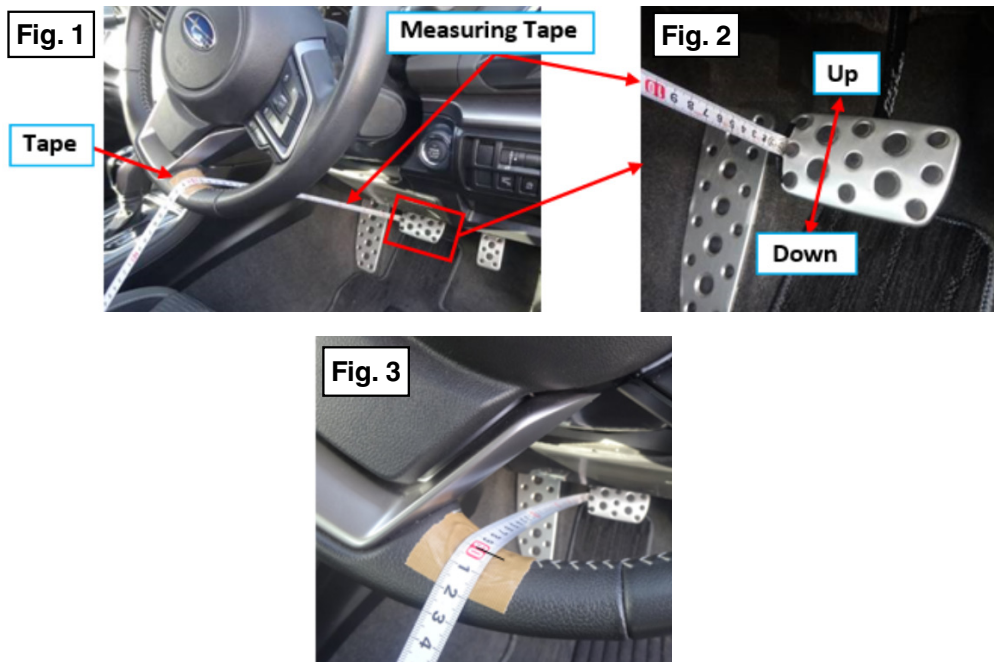
The pedal stroke specification for these models is 4mm to 6mm.

- **SLOWLY** depress the brake pedal until the brake lights illuminate. Measure the brake pedal stroke (distance from “free” position to stop light ON position) following the reference pictures below.

- If the measurement is within the standard value (4 mm - 6 mm), proceed to **11**) below and secure the conversion harness as described in **12**) below.
- If the measurement is out of standard value (less than 4 mm or more than 6 mm), repeat this step and **CAREFULLY** re-adjust the brake lamp switch position as necessary to achieve the standard value.
