PRODUCT CAMPAIGN BULLETIN

APPLICABILITY: 2013-2017 Crosstrek
 2014-2016 Forester
 2008-2016 Impreza 4-door
 2012-2016 Impreza 5-door
 2008-2014 WRX 4-door

NUMBER: WUE-90
NHTSA ID: 19V-149
DATE: 04/09/19

SUBJECT: Brake Lamp Switch Replacement

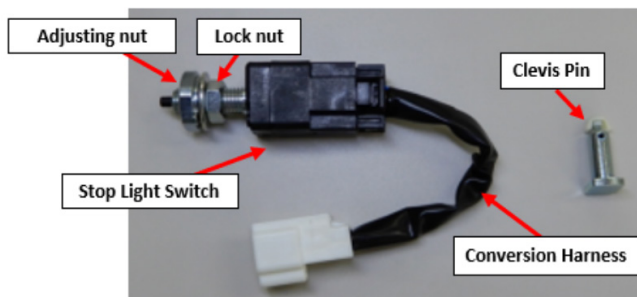
A Brake Lamp Switch Repair Kit has been established. The part number is **83319FJ000**.

- Brake Lamp Switch
- Adapter Harness
- Clevis Pin
