Cargo Tray Stop Bracket Hardware

Bulletin Type:	Recall	Publication Date:	March 2019
Bulletin #(s):	US 19V-166	Make(s):	Jayco
Job Code(s):	9901431	Model(s):	Northpoint 387RDFS“LZ”
Flat Rate(s):	.25 hour	Model Year(s):	2019

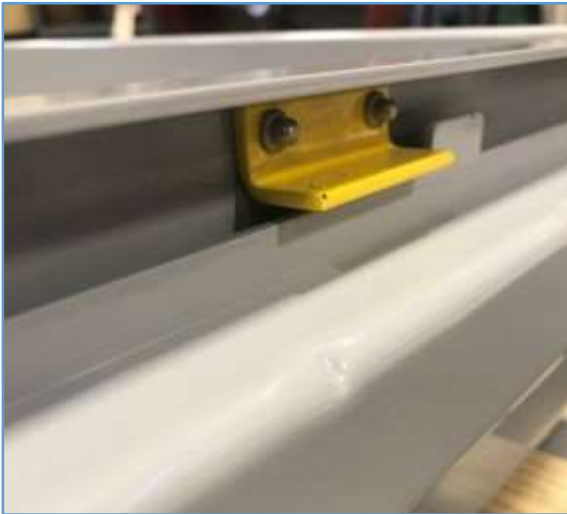
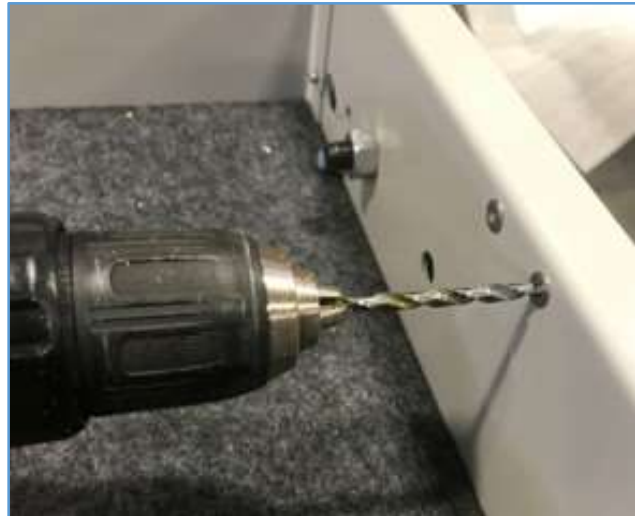
Incident:	Replace rivets in each stop bracket (2) of cargo tray
Affected Units:	2019 Northpoint K1LZ0050-0062
Parts Kit:	Parts Kit #: 19V-166
	Contents: Hardware for either repair method 4 stainless .188x0.236-335 grip structural rivet for repair method <u>2A</u> 4 #10-24 x7/16” bolts for repair method <u>2B</u> 4 10-24 Zinc plated Nylon insert lock nuts for repair method <u>2B</u>
Misc. Tools & Supplies:	Drill with 3/16" drill bit Rivet gun 1/8" Allen wrench 3/8" ratcheting type wrench

Extend the tray and drill out the 4 rivets securing the yellow stop brackets. (2 on each side of tray)

Replace one side at a time to prevent the tray from fully extending and disconnecting from the frame.
