Safety Recall **Code: 42J5**

Subject	Rear Axle (Rear Axle Coil Springs				
Release Date	April 10, 2019					
REVISION SUMMARY	Updated cl	aiming and repai	r instructions to include Criteria	02-10.		
Affected Vehicles	U.S.A. and	<i>U.S.A. and Canada:</i> Certain 2015-2019 MY Volkswagen Golf, 2017-2019 MY Golf SportWagen, 2019 MY Jetta and 2018-2019 MY Tiguan				
			n Elsa on the day of repair to verify that a aign inquiry & verification source.	a VIN qualifies for repair under this		
	✓ Car	npaign status must sł	now "open."			
			action(s), inform your customer so that th in the workshop for this campaign.	he work can also be completed at the		
Problem Description	The rear axle coil springs in affected vehicles may not have met factory specifications due to a defect in materials or because of problems in the spring production process. These issues can impact the long-term durability of the rear axle coil springs. Affected coil springs can break. A broken coil spring can damage a rear tire, become a hazard on the roadway and lead to a loss of vehicle control without warning, putting people at risk and possibly causing damage to other vehicles on the road.

Corrective Action	Replace th

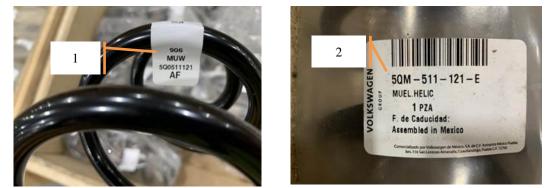
Coil spring tag (1) does not match the packaging label (2). This is OK if your parts align with the chart below.

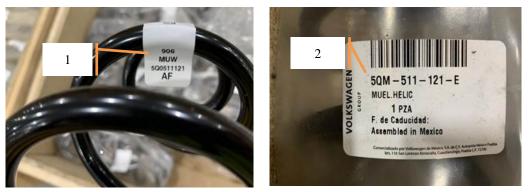
Coil spring tag (1) does not match the packaging label (2).

This is **OK** if your parts align with the chart below.
