# IMPORTANT SAFETY RECALL NOTICE

## MORryde U-Bolt Torque

MORryde has detected that Ford E-450 units that had wheelbase modification during the dates of March 6th, 2018 through April 18th, 2018, have unverified u-bolt torque and are affected by this recall. The OEM u-bolts were replaced by MORryde as part of the wheelbase modification process. This wheelbase modification service has been sold to numerous RV and bus companies.

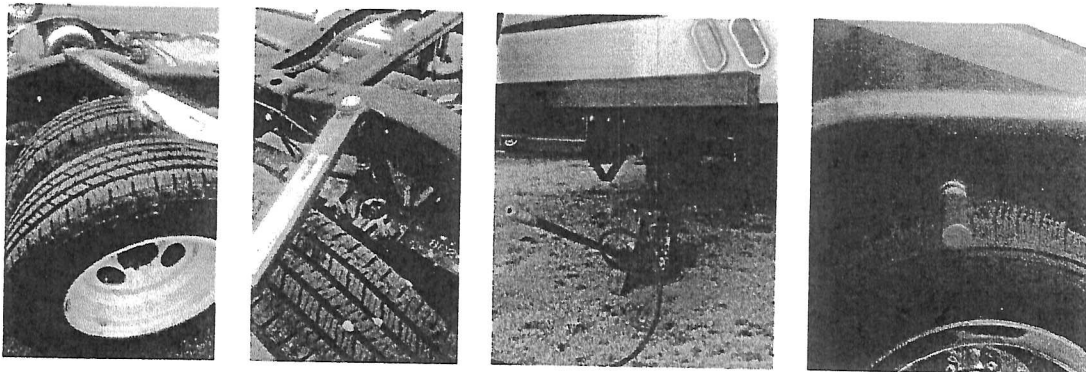
EXHIBIT A

**REASON FOR RECALL:** The u-bolts installed over the rear axle hold the leaf springs and rear axle together. Insufficient torque on the u-bolts may cause the u-bolts to loosen or break resulting in the potential for the rear axle to break away from the chassis. This could lead to loss of control over the vehicle and pose danger to the vehicle operator and other motorists.

1. Set torque wrench to 170 ft-lb.
2. The best way to access the u-bolts is straight above the rear tires facing the sidewall of the unit. It may be necessary to use an air jack or floor jack under the rear hitch or frame extensions to provide access for the torque wrench and extension to fit under the sidewall. (Exhibit A)
