SAFETY RECALL BULLETIN

February 2019
D18R7 (FL802)
NHTSA #18V-913 (Non-School Buses)
#18V-914 (School Buses)
Transport Canada #18-719 (Non-School Buses)
#18-720 (School Buses)

Subject: **Detroit™ Axle Steering Arm / Tie Rod Arm Capscrew Inspection**

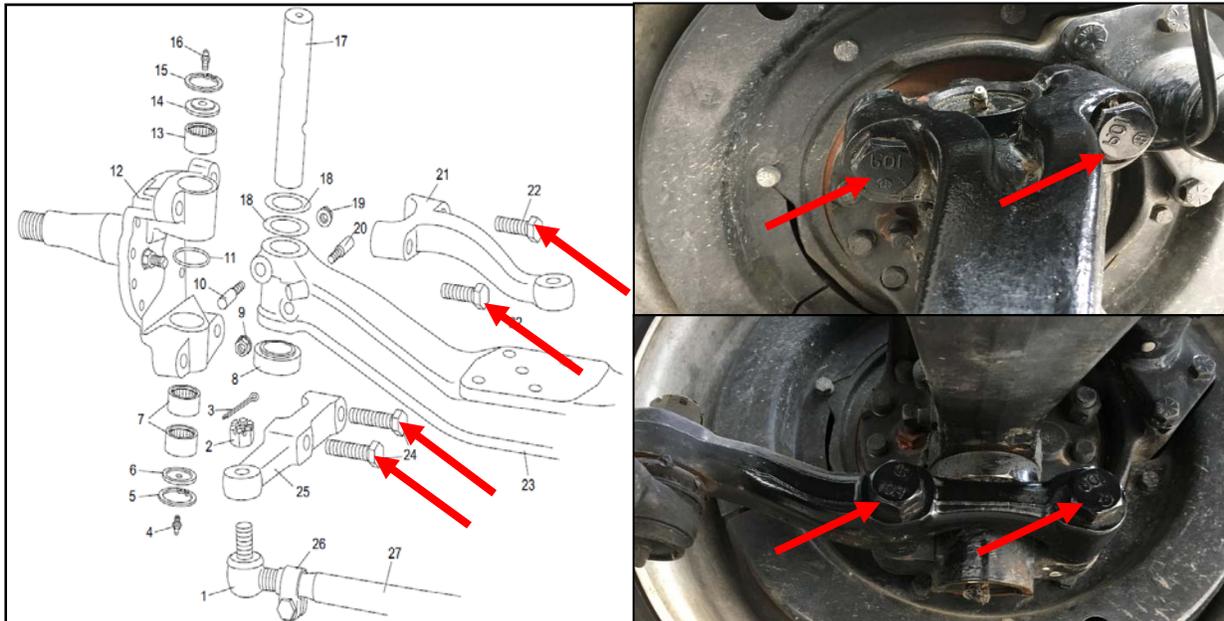
Figure 1 – Steering Arm and Tie Rod Arm Capscrew Location

2. Apply the parking brake, turn off the ignition, chock the rear wheels, and perform any other applicable safety steps.
3. Using a suitable torque wrench, check the torque on the two steering arm capscrews as well as the forward tie rod capscrew on the driver's side and the rear tie rod capscrew on the passenger's side. See Figure 1.
 - a. For Model 2 and Model 3 axles with a M20 capscrew, the torque should be checked at 525 N·m (390 lb·ft).
 - b. For Model 5 axles with a M24 capscrew, the torque should be checked at 850 N·m (630 lb·ft).

4. Are the capscrews at the correct torque?
 - a. Yes; proceed to step 5 to check the other capscrews.
 - b. No; mark which capscrews are at low torque before proceeding to step 5 to check the rest of the capscrews. Any capscrews that are below the correct torque will need to be repaired following the instructions starting in step 9.

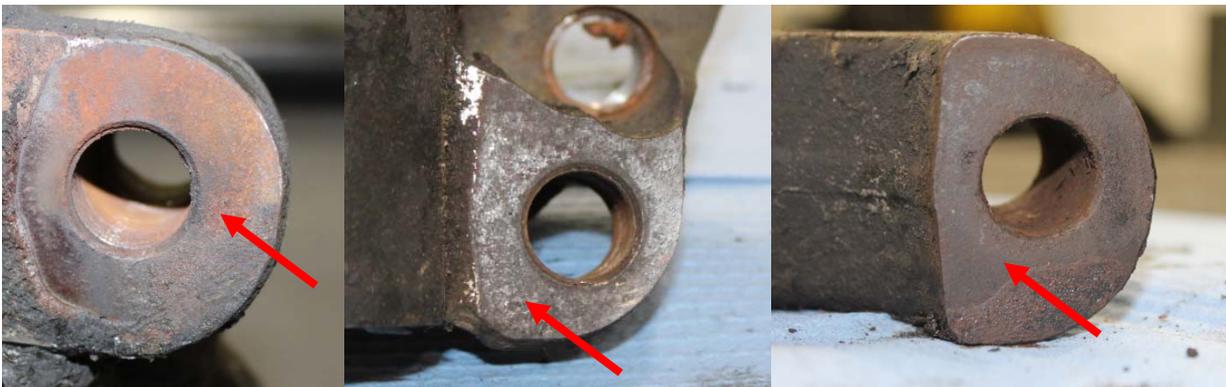
Figure 2 – Fretting Damage That May Look Like Rust from Water Intrusion at Loose Joint

11. Are the joint surfaces of either the steering or tie rod arm or steering knuckle damaged?
 - a. Yes; proceed to step 12 to replace the knuckle and the arm.
 - b. No; proceed to step 14 to replace the capscrews only.
12. **Remove the steering or tie rod arm and steering knuckle. Reference** section “Dissassembly of the Steering Knuckle” in the Front Axles chapter of the *Detroit Axles Manual* (DDC-SVC-MAN-0141).
13. **Install a new steering or tie rod arm and new steering knuckle. Reference** section “Assembly of the Steering Knuckle” in the Front Axles chapter of the *Detroit Axles Manual* (DDC-SVC-MAN-0141).
14. **Install two new steering or tie rod arm capscrews. Reference** section “Assembly of the Steering Knuckle” in the Front Axles chapter of the *Detroit Axles Manual* (DDC-SVC-MAN-0141).
15. Repairs are complete.

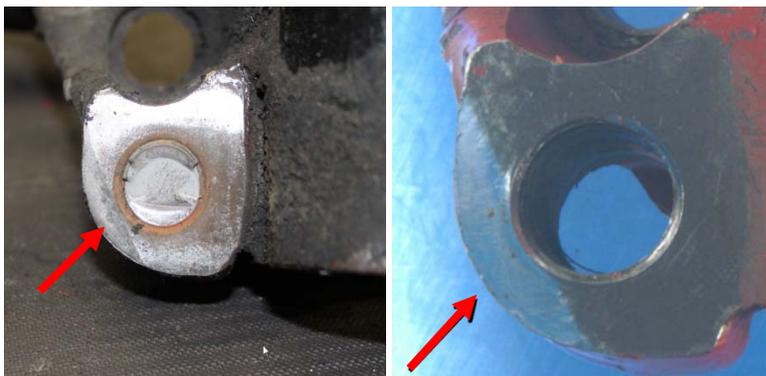
Figure 3 – Dent at the Loose Joint
