PRODUCT CAMPAIGN BULLETIN

APPLICABILITY: 2009-2013 Forester
 2008-2014 Impreza
 2005-2014 Legacy
 2005-2014 Outback
 2006-2008 Tribeca

NUMBER: WUF-91R
NHTSA: 19V-297
DATE: 04/15/19
REVISED: 04/30/19

SUBJECT: Replacement Ignition Switch Recall

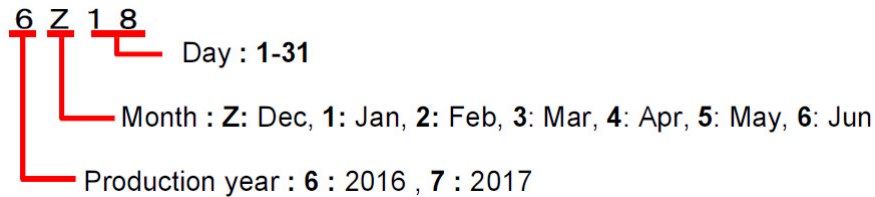
4. Confirm the Lot Number on the face of the ignition switch using the chart below.

Using the chart above as a guide, if the Lot Number is between **6Z18** (December 18, 2016) and **7602** (June 2, 2017), the ignition switch MUST be replaced. If the Lot Number is illegible, REPLACE the ignition switch assembly.

NOTE: Always record the ORIGINAL ignition switch Lot Number on the hard copy of the Repair Order as it will be required for claim submission.

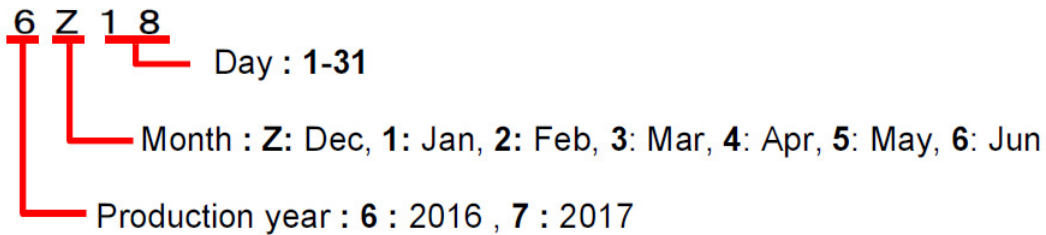
3. Remove the ignition switch from the ignition lock assembly.
4. Confirm the Lot Number on the face of the ignition switch using the chart below.

Using the chart above as a guide, if the Lot Number is between **6Z18** (December 18, 2016) and **7602** (June 2, 2017), the ignition switch MUST be replaced. **NOTE:** If the Lot Number is illegible, **REPLACE** the ignition switch assembly.

5. **CAUTION:** After reinstalling the ignition switch back into the lock housing, torque the 2 retaining screws to 1.1 Nm (9.7 inch-pounds). **DO NOT OVER-TIGHTEN.** Confirm all functions of the ignition switch (OFF, ACC, ON, and START). With the engine OFF and parking brake fully engaged, confirm the function of the ignition interlock by attempting key removal in a gear other than park. Proceed to Step 5 below.

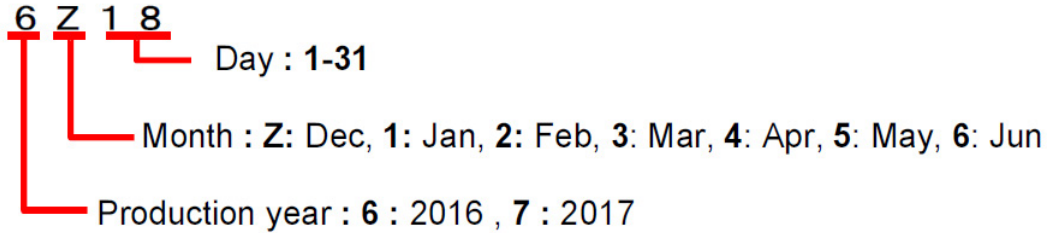
4. Confirm the Lot Number on the face of the ignition switch using the chart below.
NOTE: If the Lot Number is illegible, REPLACE the ignition switch assembly.

Using the chart above as a guide, if the Lot Number is between **6Z18** (December 18, 2016) and **7602** (June 2, 2017), the ignition switch **MUST** be replaced. **NOTE:** If the Lot Number is illegible, REPLACE the ignition switch assembly.

5. **CAUTION:** After reinstalling the ignition switch back into the lock housing, torque the 2 retaining screws to 1.1 Nm (9.7 inch-pounds). **DO NOT OVER-TIGHTEN.** Confirm all functions of the ignition switch (OFF, ACC, ON, and START). With the engine OFF and parking brake fully engaged, confirm the function of the ignition interlock by attempting key removal in a gear other than park. Proceed to **Step 5** below.
