PRODUCT CAMPAIGN BULLETIN

APPLICABILITY: 2009-2013 Forester
 2008-2014 Impreza
 2005-2014 Legacy
 2005-2014 Outback
 2006-2008 Tribeca

NUMBER: WUF-91
NHTSA: 19V-297
DATE: 04/15/19

SUBJECT: Replacement Ignition Switch Recall

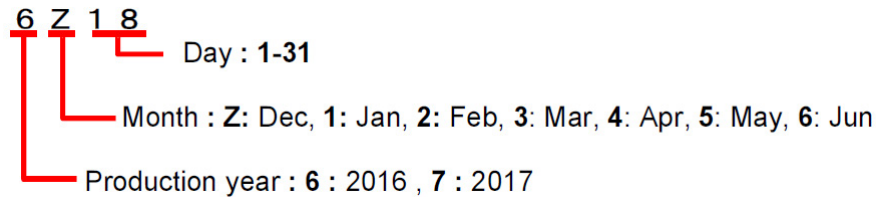
4. Confirm the Lot Number on the face of the ignition switch using the chart below.

Using the chart above as a guide, if the Lot Number is between **6Z18** (December 18, 2016) and **7602** (June 2, 2017), the ignition switch MUST be replaced. If the Lot Number is illegible, **REPLACE** the ignition switch assembly.

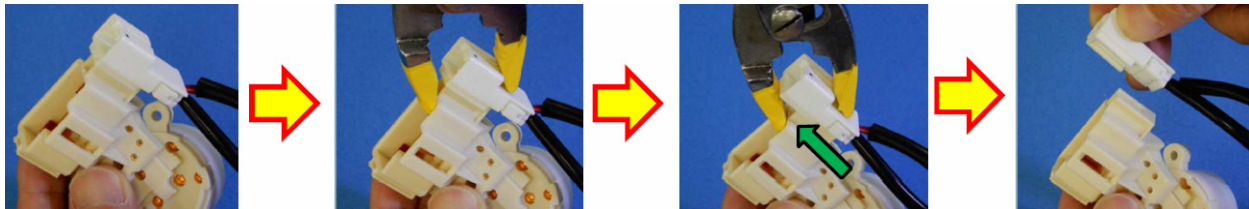
- If replacing the ignition switch on one of these models, **CAREFULLY** removing the key lock solenoid connector from the ignition switch by using pliers as shown below and swap it over to the new switch. Apply electrical tape to the plier jaws to protect the connector.
- If the connector or wiring is damaged, the ignition steering lock assembly will require replacement including recoding of the new assembly to match the original keys by a certified locksmith.
- **NOTE:** Removing the key lock solenoid connector, as shown in the sequence below, is only required if the ignition switch requires replacement.

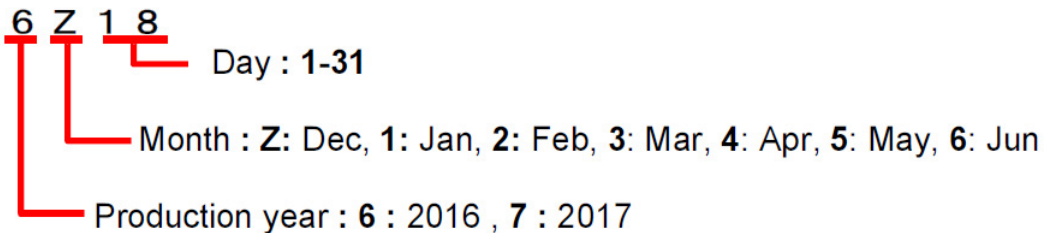
3. Remove the ignition switch from the ignition lock assembly.
4. Confirm the Lot Number on the face of the ignition switch using the chart below.

Using the chart above as a guide, if the Lot Number is between **6Z18** (December 18, 2016) and **7602** (June 2, 2017), the ignition switch MUST be replaced. **NOTE:** If the Lot Number is illegible, **REPLACE** the ignition switch assembly.

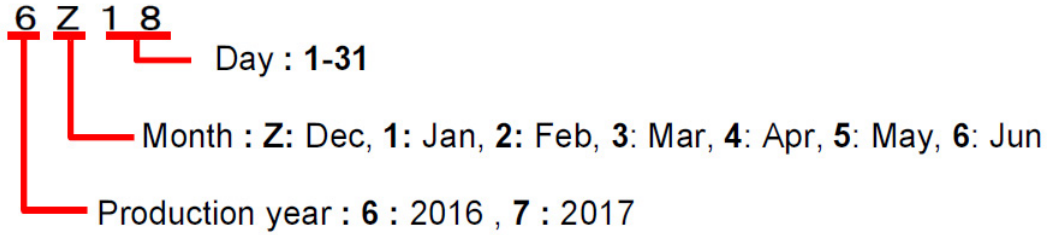
4. Confirm the Lot Number on the face of the ignition switch using the chart below.
NOTE: If the Lot Number is illegible, REPLACE the ignition switch assembly.

Using the chart above as a guide, if the Lot Number is between **6Z18** (December 18, 2016) and **7602** (June 2, 2017), the ignition switch **MUST** be replaced. **NOTE:** If the Lot Number is illegible, REPLACE the ignition switch assembly.
