May 24, 2019

Version 3

Safety Recall: 2018-19 Odyssey Check Park Mechanism, Battery Terminal Inspection, and Update TCM

Supersedes 19-046, dated May 1, 2019, to revise the information highlighted in **yellow**

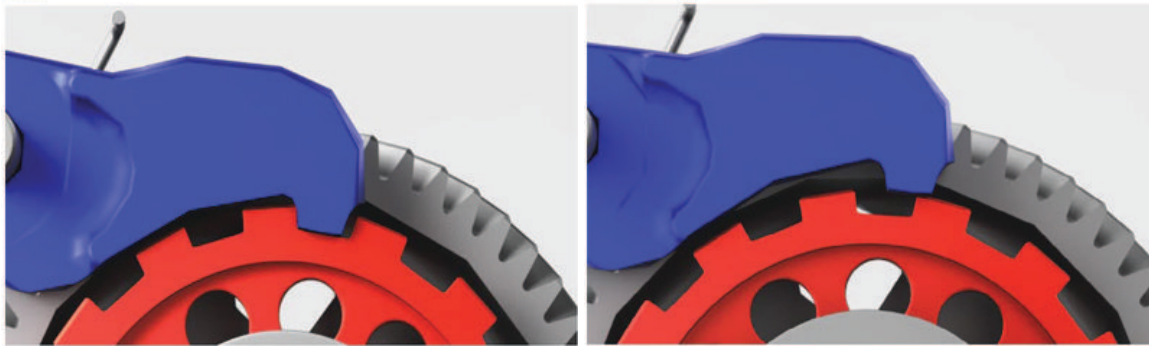
**NO GOOD - Does NOT Hold in Park**

No - If it did not hold in Park, send the snapshot to Tech Line using the RO number, then go to REPAIR PROCEDURE B.

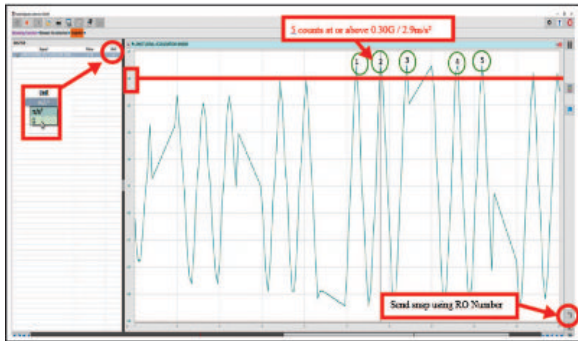
Did the vehicle stay in Park while you got at least five counts above 0.30 G//2.9 m/s²?

The parameter display can be changed by selecting the current display unit.

Yes - Send the snapshot to Tech Line using the RO number, then go to step 13. If it stayed in Park but you failed to get at least five peak counts of or above 0.30 G//2.9 m/s², **make sure the vehicle is on a surface with good traction.** Then, repeat steps 10 thru 12.

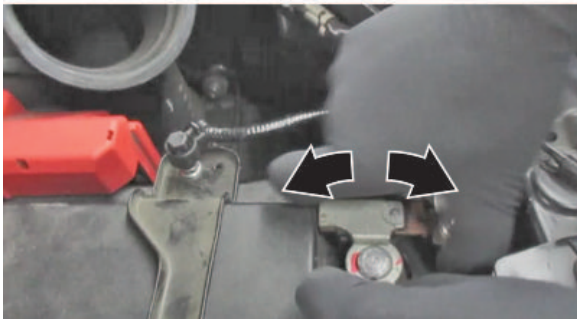
5. Make sure the connection is tight by wiggling the terminals back and forth.

Are both terminals secure?

Yes - Apply multipurpose grease to the terminals to prevent corrosion, and install the air intake duct and the bulkhead cover. Then, go to TCM UPDATE.

No - Go to TERMINAL REPAIR.

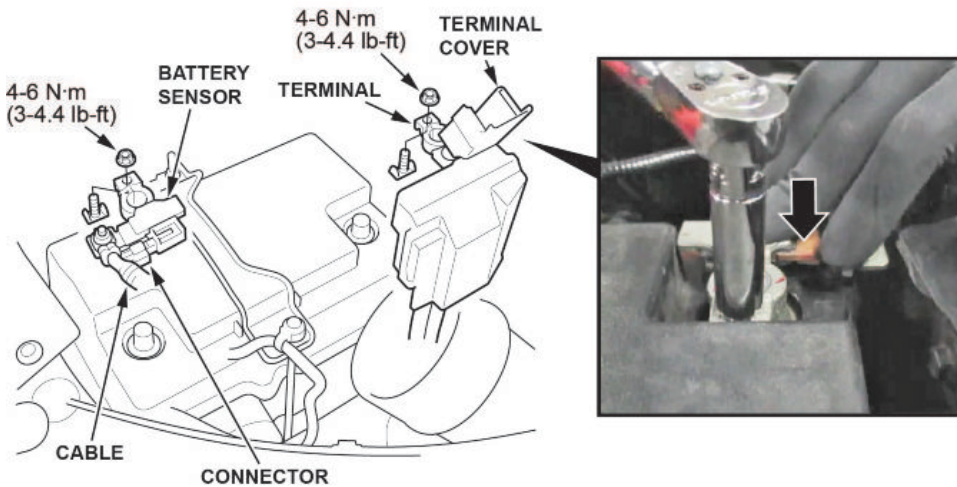
2. While holding down the terminal, torque both positive and negative clamps to **4-6 N•m (35-53 lb-in)**.

- Do not over torque the terminal.
- Always connect the positive side first.

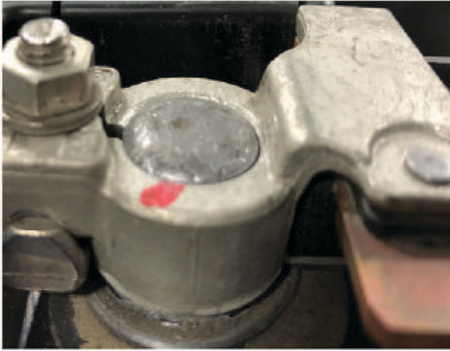
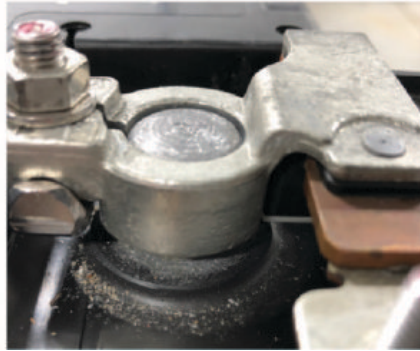
3. Compare both of the battery terminals to the examples below.

Do the battery terminals look like the good example?

No - Go to BATTERY REPLACEMENT, BATTERY RESISTANCE RESET PROCEDURE.
