June 13, 2019

Safety Recall: 2018-19 Odyssey Check Park Mechanism (Snapshot Upload Required), Battery Terminal Inspection, and Update TCM

Supersedes 19-046 Safety Recall: 2018-19 Odyssey Check Park Mechanism, Battery Terminal Inspection, and Update TCM, dated May 24, 2019, to revise the information highlighted in **yellow**

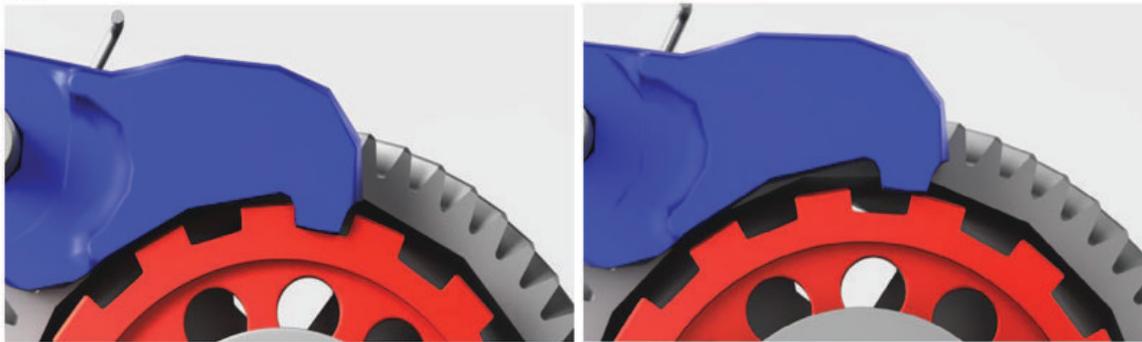
**NO GOOD - Does NOT Hold in Park**

No - If it did not hold in Park, send the snapshot to Tech Line using the RO number, then go to REPAIR PROCEDURE B.
