IMPORTANT SAFETY RECALL

NHTSA Safety Recall No. 19V-303

MANDATORY ACTION BULLETIN

Rotation Bearing Fastener Inspection

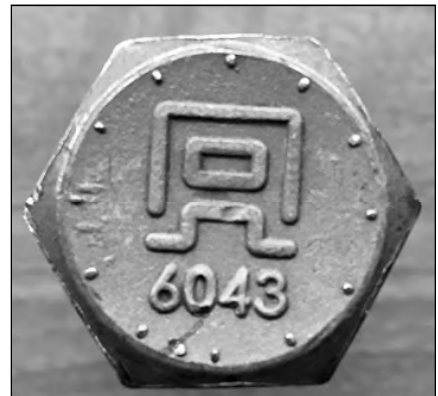
Figure 1 — 6043 Head Marking

This Mandatory Action Bulletin requires the inspection of rotation bearing fasteners before using the unit again. Altec received reports of a number of rotation bearing fasteners that broke during the annual torque inspection. **Death or serious injury can result from uncontrolled movement. The failure of rotation bearing fasteners can cause uncontrolled movement.**

- Look for any broken or missing fastener heads
- Look at all the fastener heads on the inner race to see if there is a 6043 below the Altec logo (refer to Figure 1)

If **any** of the fasteners have a head with the head stamp of 6043 or there is a broken or missing fastener head, **remove the unit from service.**

If fasteners marked with 6043 are found on the inner race, all of the fasteners on that race must be replaced before the unit can be returned to service. Order the replacement fastener kit by calling 1-877-GO ALTEC (1-877-462-5832) and select Prompt 1. Refer to Section 6 in the Maintenance Manual for replacement Instructions.
