A182202370 Lower Control Arm Weld

Release Date: July 2019 Revision: 05

Condition	General Motors has decided that a defect which relates to motor vehicle safety exists in certain 2017-2019 model year Chevrolet Trax and Tracker vehicles. In some of these vehicles, a joint in one or both front lower-control arms may have been improperly welded. Over time and in rare cases, an improperly welded joint can fatigue and break, causing the lower-control arm to partially separate from the vehicle.
Correction	All lower control arms will be inspected using a gauge tool to determine if they meet manufacturing specifications. Please note, this is for the Trax only in the USA and Canada. Dealers will replace lower control arms that do not pass the gauge inspection.

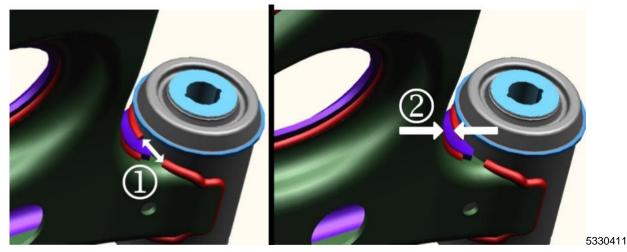
Photograph of Gap 1 (between the welds, red) and Gap 2 (between the control arm body and bushing barrel, purple).

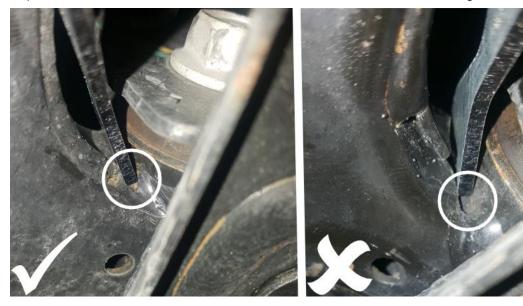
- 5339559
- 4. Inspect the Gap (1) in the weld using the number one (1) side of the gauge. With the gauge oriented as shown, slide the top of the tool along the barrel of the bushing until it contacts the upper weld. Then, pivot the bottom of the gauge in while holding the top against the upper weld until the bottom of the tool is also contacting the bushing barrel or weld.
 - If the inspection gauge does **not** fit in the gap between the welds (check mark), the control arm is good.
 - If the inspection gauge **does** fit in the gap between the welds (X), the control arm is <u>bad</u> and must be replaced.

- 6. Replace any front control arms that failed inspection. Refer to Lower Control Arm Replacement in SI.
- 7. Lower the vehicle. Refer to Lifting and Jacking the Vehicle in SI.
