A. VEHICLE INSPECTION PROCEDURE

2009 Mazda6 (HP) and 2010-2013 Mazda6 (HZ) vehicles, which were originally sold in, or currently or previously registered in Salt Belt States listed below.

B. CROSS MEMBER INSPECTION PROCEDURE 2009-2013 MAZDA6

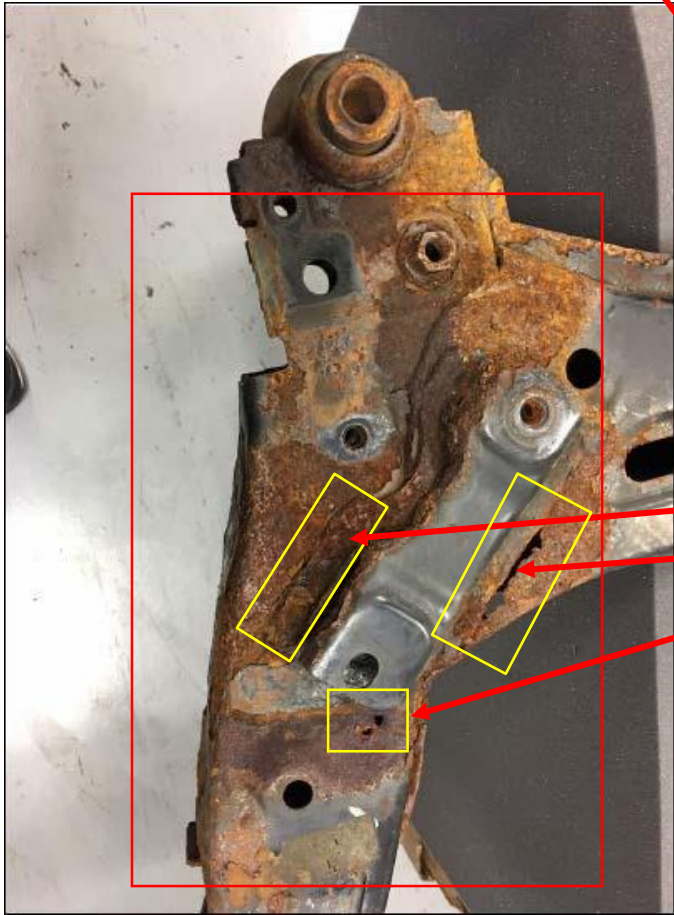
Top View: Used Cross member

Zone 1 inspection Area: Top Surface
Look for holes or cracks along the top surface in these areas. If a hole or crack is present, the cross member needs to be replaced. This cross member fails inspection as there is perforation

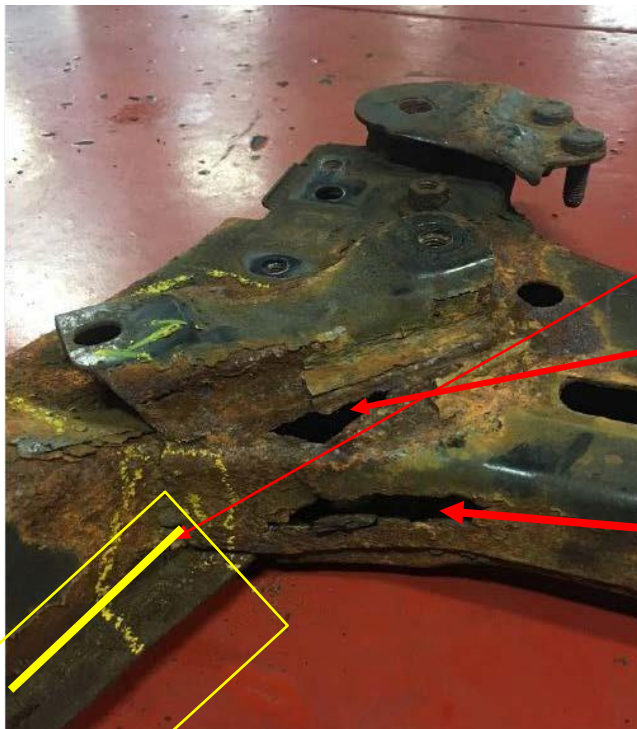
Inside Top View: Damaged Cross member

Look for perforation or crack along the flange in this area. If a crack or perforation is present, replace the cross member.

Top side Zone 1 Failure due to perforation. Replace

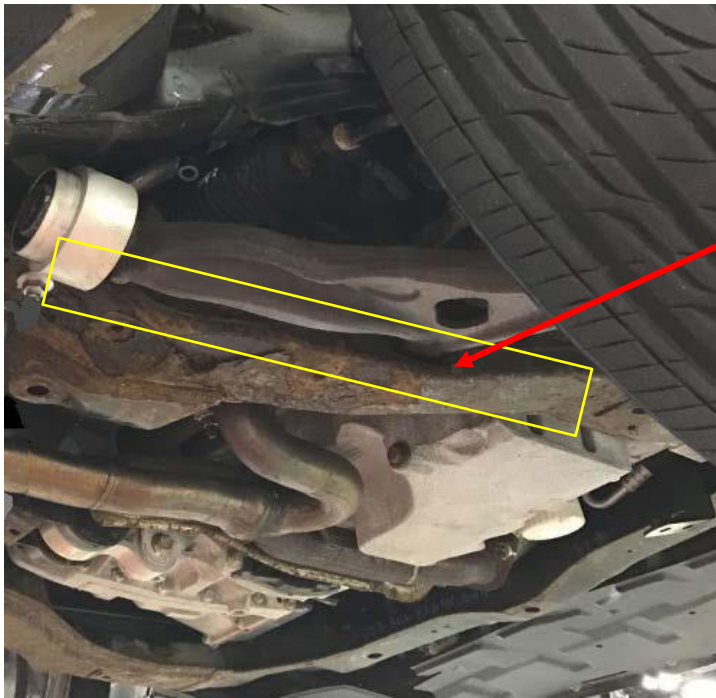
Side View: Non-Damaged Cross member

Zone 3 inspection Area:
Look for perforation especially along the bottom corner ridge line (this area). If perforation or a crack is present the cross member needs to be replaced.

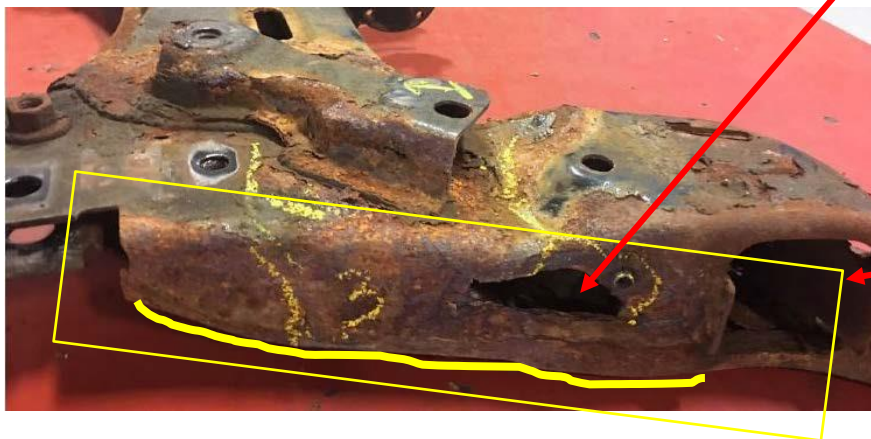
Top Side View: Damaged Cross member

This cross member passes inspection even with the perforation as the bracket supports and covers the hole. If perforation is visible beyond what the bracket covers, the cross member must be replaced as it will fail a state safety inspection for perforation.

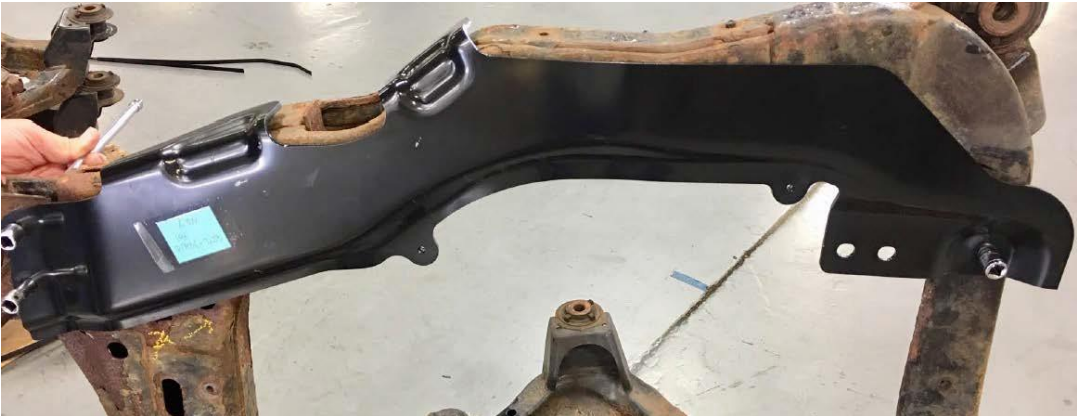
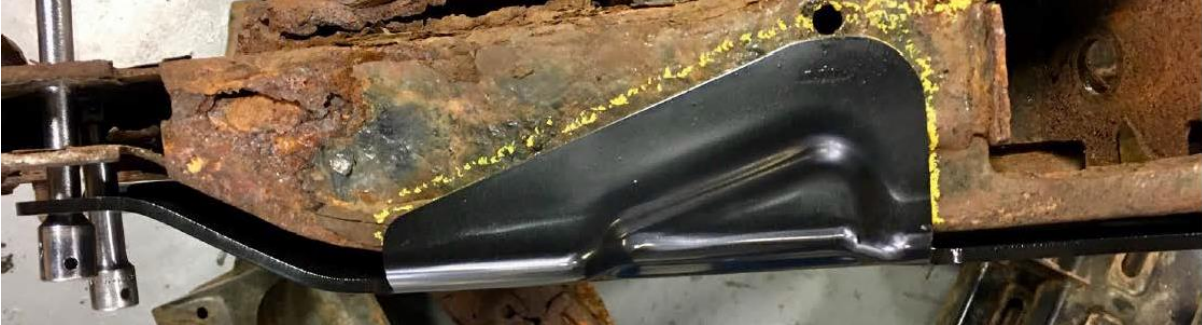
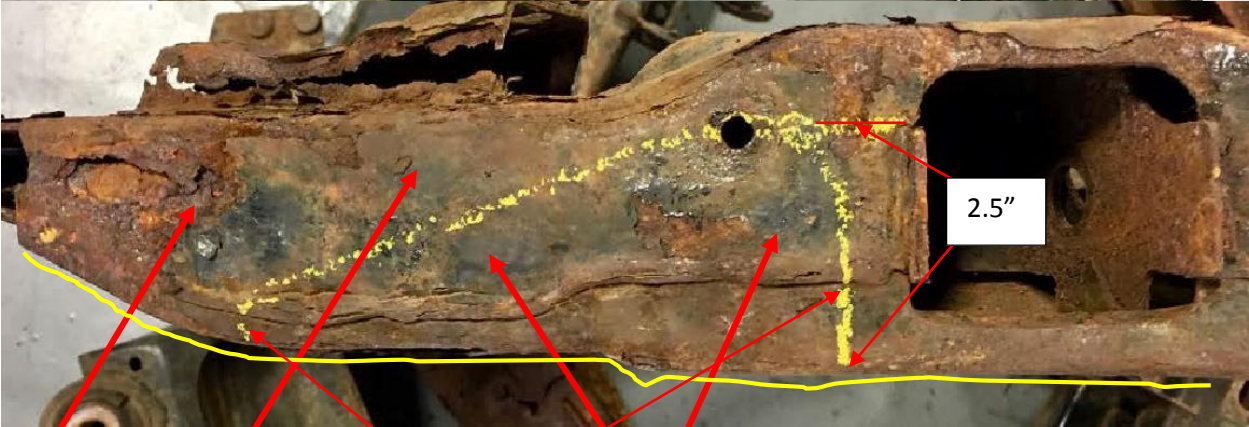
Photos of the bracket installation

Perforation in this area is not covered by the bracket and will fail State Inspection.

6.5 " Perforation in this area is covered by the bracket and is ok to use the cross member.
