H208NAS1

TECHNICAL BULLETIN

SAFETY RECALL: Seatbelt Tension Sensor Connector Wiring

MODEL:	MODEL YEAR:	VIN:	ASSEMBLY PLANT:
F-TYPE (X152)	2014-2015	K00001-K19747	Castle Bromwich

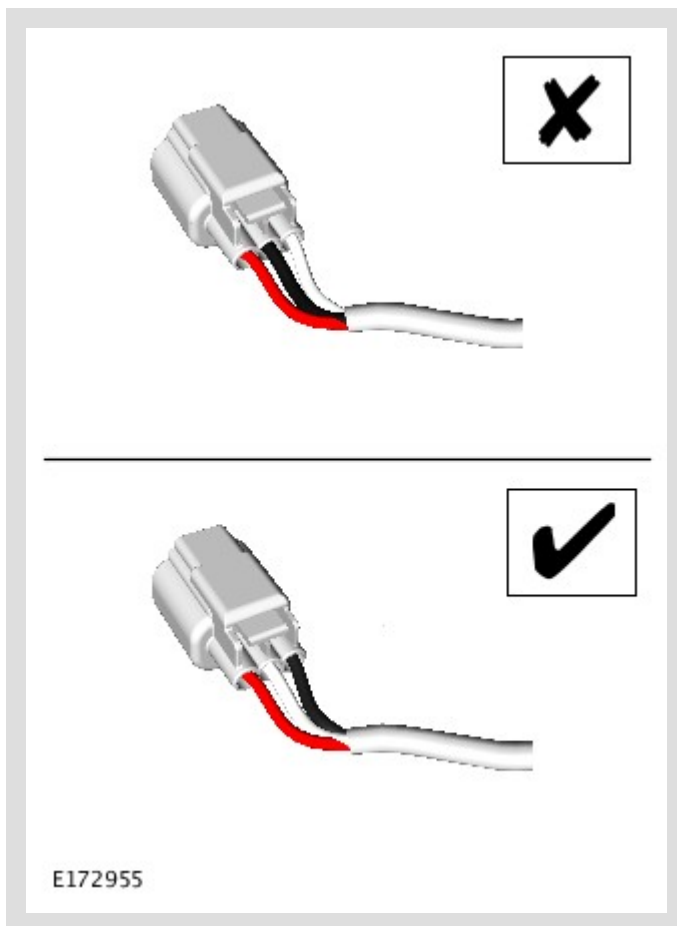
4

At the seatbelt tension sensor side of connector C3R210, inspect that the electrical connector wires are positioned in the correct pin location as shown[✓].

- If the wires **are** in the correct position [✓], **reverse steps 1-3 and release the vehicle.**
- If the wires **are not** in the correct position [X], **continue to step 5.**
